# Quantifying corrosion in volcanic ash and gas environments

**Prepared by: Carol Stewart<sup>1</sup>, Zhengwei Li<sup>2</sup>, Anna de Raadt<sup>2</sup> and Kelvin Tapuke<sup>1</sup>**

1 Massey University, 2 BRANZ Ltd

June 2026

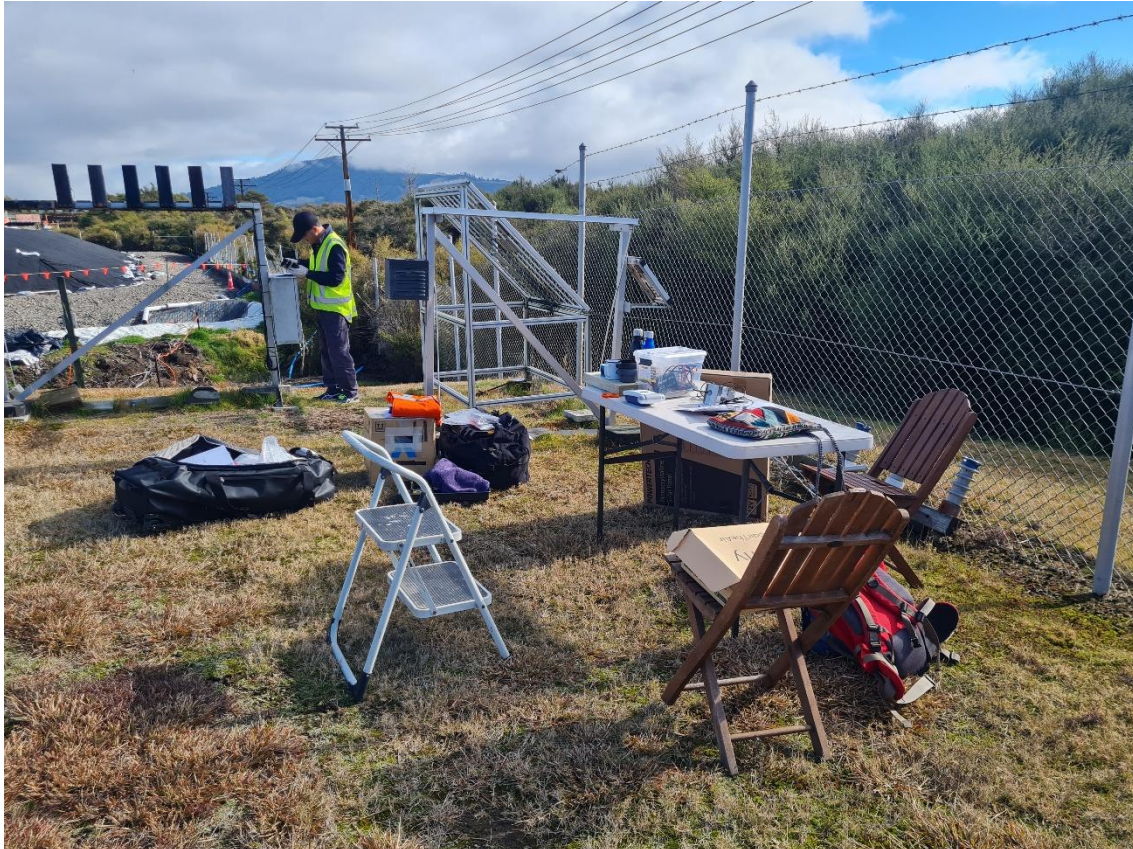
Figure 3 View of WWTP deployment site

The field deployment was carried out on 16 July (WWTP site, Figure 3) and 17 July (airport site) 2024 by team members CS, ZL, and KT.

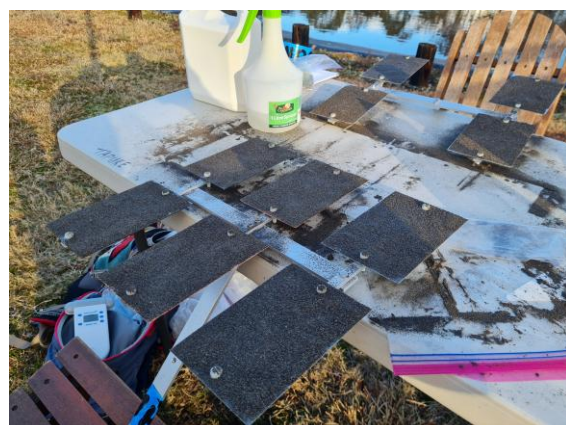
Figure 4 Dosing coupons with ash in the field.

Coupons were laid out on a table and then dosed with ash (Figure 4). Due to the smooth surface of the coupons and the installation at 45 degrees from vertical, it was necessary to lightly wet the surface of each coupon with a fine mist dispersed from a spray bottle to ensure that the ash would adhere to the metal surfaces. A solution of deionised water acidified to pH 5.0 with 10% sulphuric acid, to simulate rainfall partly acidified by contact with volcanic plumes, was used for the mist. Ash was then dispersed over coupons by shaking through a sieve to a thickness of approximately 1 mm and then allowed to dry in place prior to installation on exposure racks.

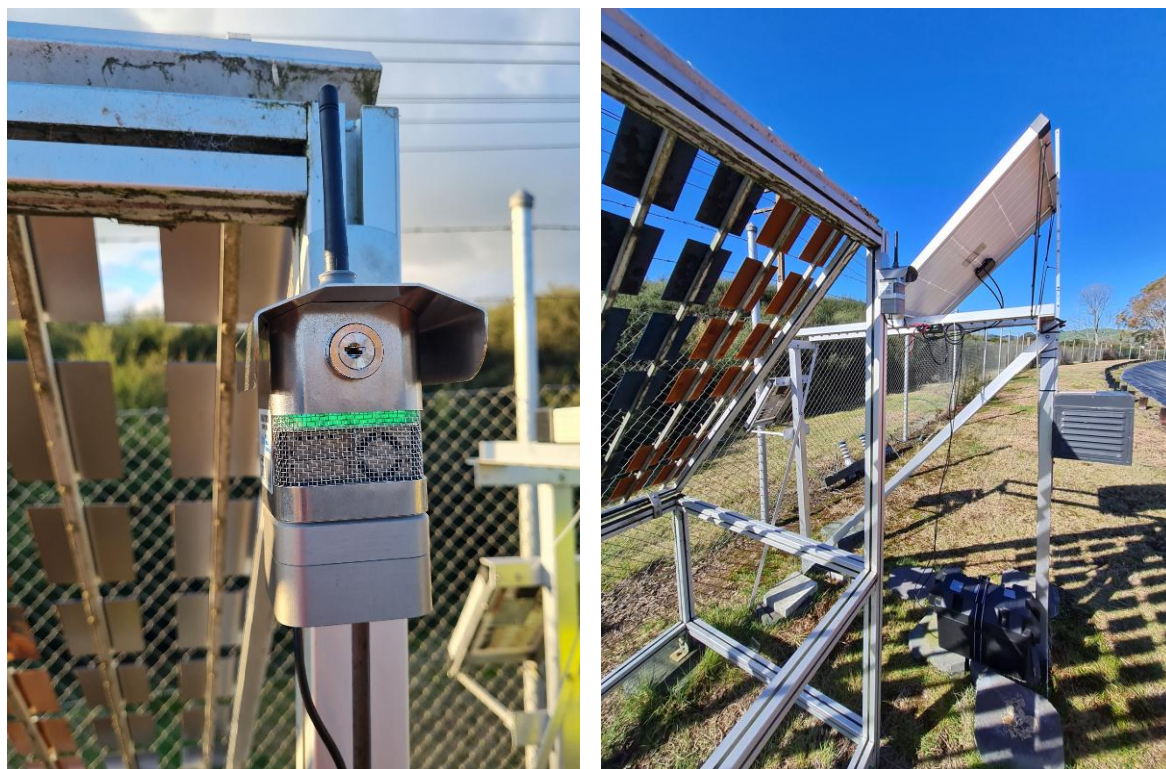
Figure 6 Air quality sensor installed at wastewater treatment plant site. (a) Airly sensor and (b) solar array.

An Airly air quality sensor (Figure 6a) was installed at the WWTP site on 16 July 2024. This sensor monitors airborne particulate matter ( $PM_{10}$ ,  $PM_{2.5}$  and  $PM_{10}$ ),  $SO_2$ ,  $H_2S$ , temperature, relative humidity, pressure and wind speed and direction. As the site had no access to mains power, power was supplied by a solar array (Figure 6b) using a 12 V 80 W solar panel and 12 V 9 Ah battery, which we replaced firstly with a 12 V 12 Ah battery and then with a 12 V 100 Ah battery after repeated problems. In total the sensor operated for 303 days over the year-long deployment period. Data was sent over the mobile network to Airly's data platform (Figure 7) from where we downloaded it.

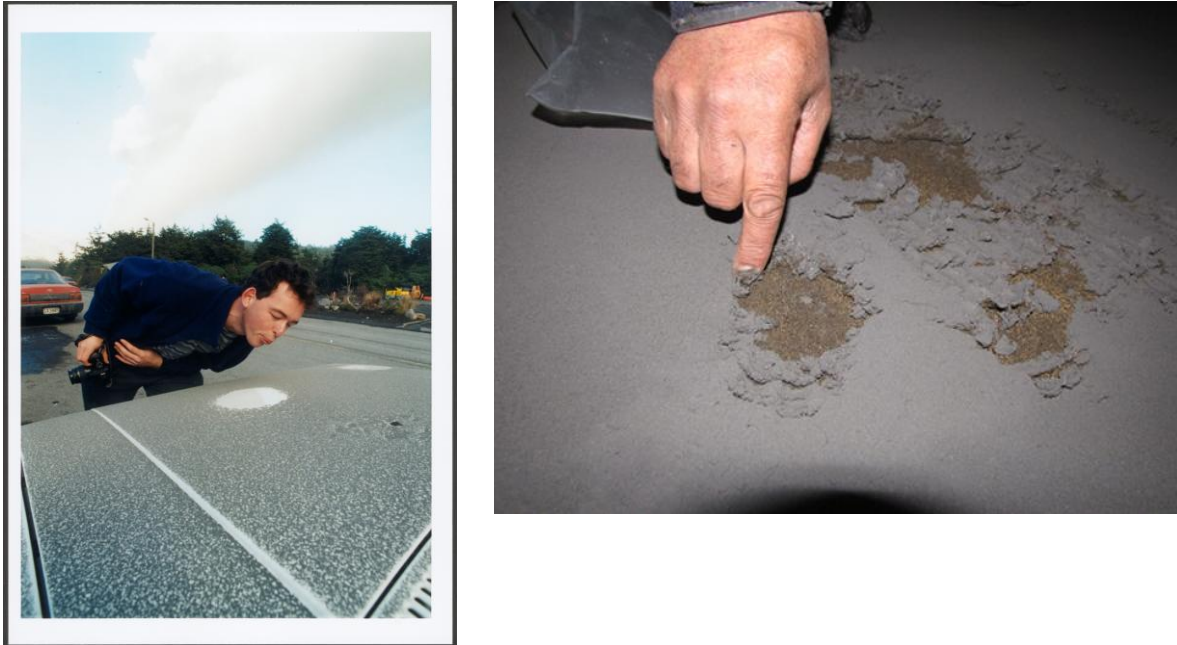
A further consideration is the state of the fresh ash deposits, which can range from dry, loose and unconsolidated to damp and clayey. Both states have been observed in ashfalls from recent eruptions in New Zealand (Figure 41). Dry, loose ash may be readily removed

by wind and rain, although in light wet weather conditions such as fog or light rain the deposit may 'cement' in place. Conversely, damp clayey ash is likely to stick to surfaces on buildings and other infrastructure but may dry out over time and become more unconsolidated. Future work could investigate the influence of the ashfall state on the initiation of corrosion processes.

Figure 41 Contrasting properties of fresh ashfall from two recent New Zealand eruptions. On left: fresh dry ashfall from 17 June 1996 eruption of Ruapehu, at Whakapapa village. Photo credit: P.J. Reid, Evening Post, photo purchased from Alexander Turnbull Library, Wellington. [/records/22793799](#) On right, damp clayey ashfall from 6 August 2012 eruption of Tongariro volcano, photo credit Bubs Smith.
