**IN THE HIGH COURT OF NEW ZEALAND
WHANGANUI REGISTRY**

**CIV-2016-483-16
[2019] NZHC 2176**

JUDGMENT OF CULL J

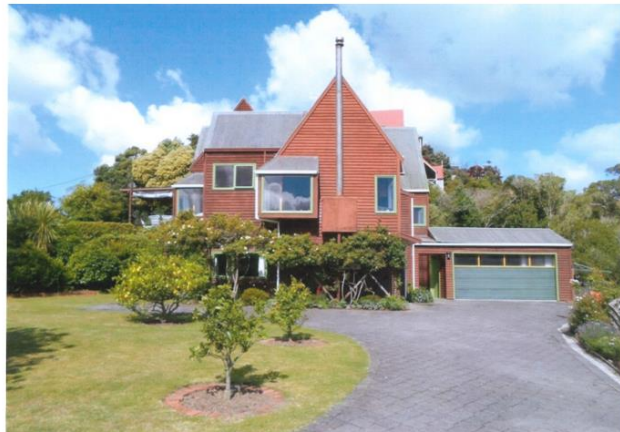
[10] One of the landslips was at the Goodiers' Property on Shakespeare Road, which winds up Bastia Hill. The Property sits on the crest of the hill, with access by a reasonably steep driveway off Shakespeare Road, which runs over the crest of the hill and levels out onto a flatter paved area leading to the house. A building platform was formed for the house by cutting into the crest of the hill to create a flat area and some stepped benches. The soil on the outer edge of the southward slope was fill that had been excavated to create a platform where the house was originally built in 1975. The garage was built in 1989, some 14 years later.

[11] During the storm, the saturated, predominantly loose, fill soils on the edge of the southward slope both above and below retaining walls mobilised in a shallow but wide landslip, taking away the four retaining walls and a portion of the driveway. The landslip caused part of the paved driveway to collapse and evacuated soils under the southwest of the garage.

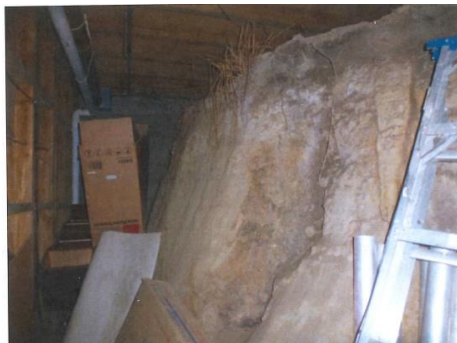
[98] Mr Peters concluded that the soils that slipped in the June 2015 landslip did not comprise any of the undisturbed silt and sand deposits of the type that existed under the house. They comprise solely the soils that have been excavated and placed downslope, together with some of the natural-formed softer soils which underlay the fill. He illustrated this by means of a photograph, which shows the house embedded on the stiff/dense building platform.

[97] In contrast, however, nearly half of the garage was likely to have been founded initially on the silts and sands of the Shakespeare Group overlain with a natural mantle of more weathered soils and colluvium. Mr Peters said it is likely to be for this reason that the builder of the garage added a pile at the southwest corner and thickened the perimeter ring foundation in the corner of the garage to better support the garage. Comparatively, the soils around and beneath the pile and supporting the retaining walls and driveway were fill-type soils. It is these soils that evacuated during the landslip.

[99] In his view, the landslip was a combination of a rotational and translational landslip that resulted in a saturated debris flow down the slope below. It was triggered

by the heavy rainfall event on 20 and 21 June 2015, and the landslide was primarily the result of a reduction of the effective strength of the near soils at the top of the slope, because of their saturation and softening by the heavy rainfall. The mechanism for the landslide, therefore, was the saturation of the predominantly loose-fill soils on the edge of the slope, both above and below the retaining walls, which were not robust enough to resist failure. Once the ground started to move, the walls collapsed and evacuated along with the soils.
