Subject: Final Report – Utility of ATC 145/FEMA P2335 guidelines for New Zealand buildings based on practitioner review

I write in relation to our now completed project, *ATC 145 Guide for repair of earthquake damaged buildings to achieve future resilience* (Contract 3443).

This letter represents our Final Report for the project. The final ATC 145 report was published during May 2025 as *FEMA P-2335: Guidelines for Post-Earthquake Repair and Retrofit of Buildings Based on Assessment of Performance-Critical Damage* (the **guidelines**). The guidelines are now freely and publicly available, and can be downloaded from <https://www.atcouncil.org/docman/fema/340-fema-p-2335-508>.

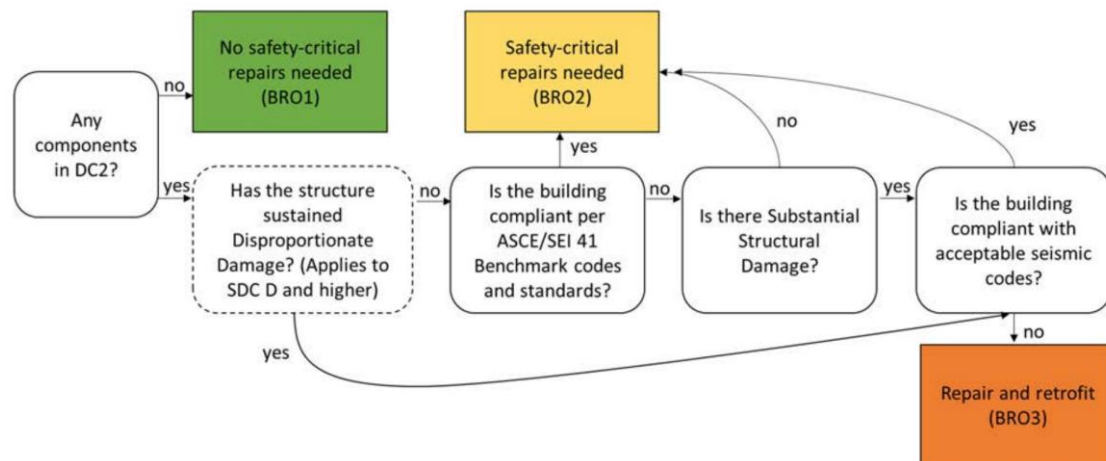
Figure 1 shows an overview of the evaluation procedure described in the guidelines, with “components in DC2” being building elements that have reduced capacity as a result of an earthquake. There are marked differences between the U.S. Building Code framework on which the guidelines are based and the New Zealand Building Code framework. These differences are identifiable even at the high-level represented by Figure 1:

Figure 1: FEMA P2335 flow chart showing process for evaluation of earthquake damage

- The U.S. does not have legislative requirements comparable to New Zealand’s earthquake prone building (EPB) regime. The EPB regime means that even a building with no significant structural damage may be required to be retrofitted if a Building Consent is required to complete (non-structural) repairs.
- Additionally, New Zealand does not have an equivalent of “benchmark codes” that are used in the U.S. to deem modern buildings to have sufficient capacity without further calculation.

Both of these points of difference would result in more engineering effort being required to apply the guidelines under current legislative settings in New Zealand.

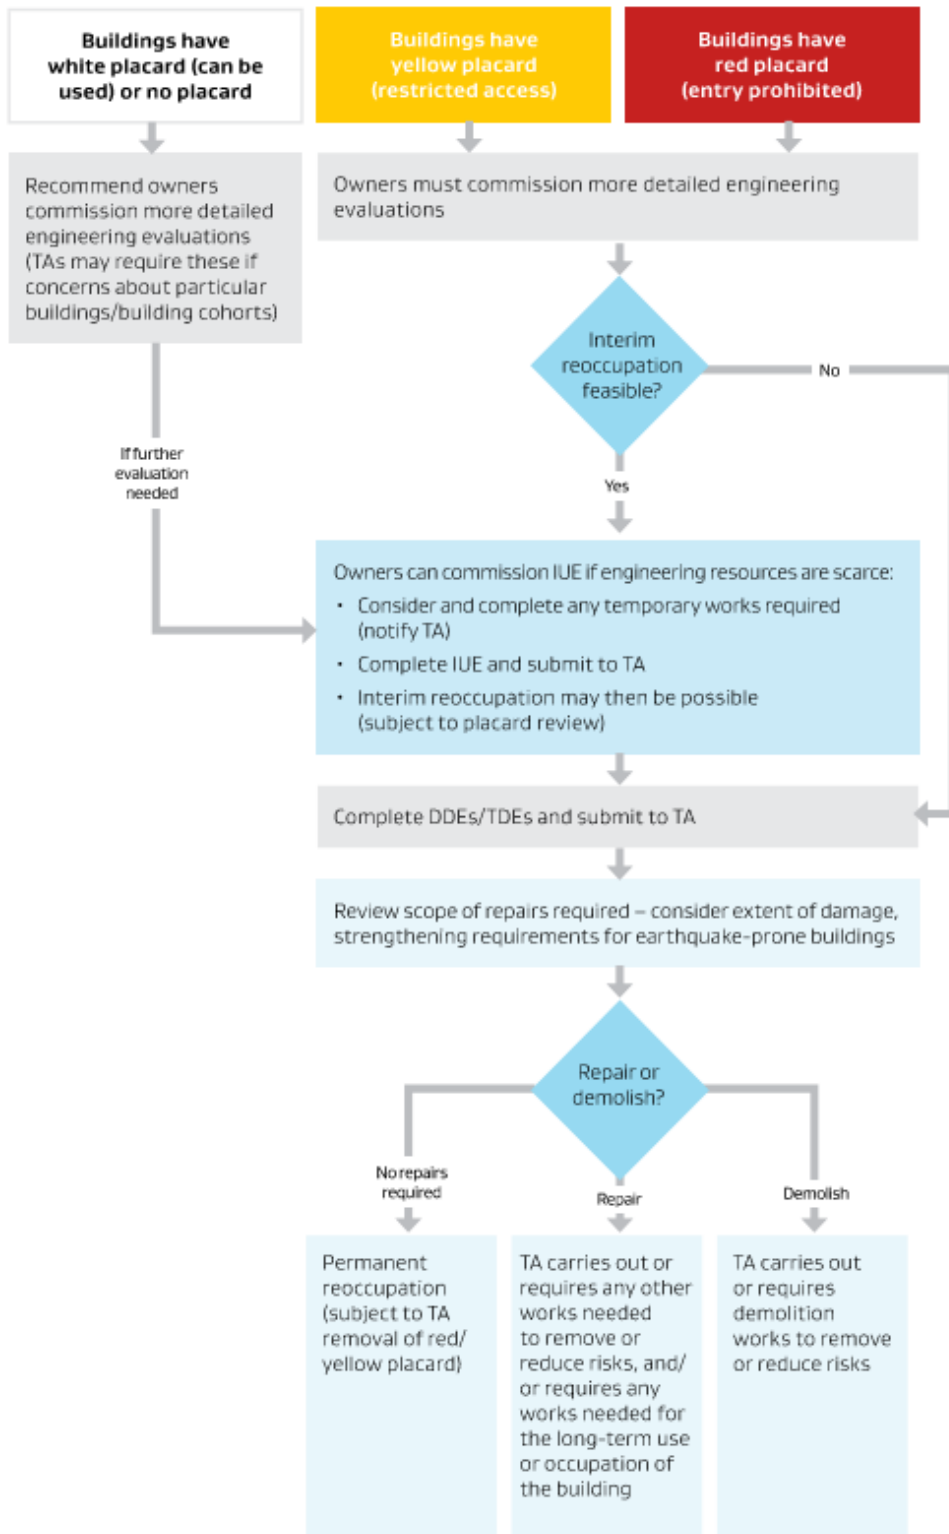
Figure 1 below from MBIE (2020) summarises the recommended assessment process for non-residential buildings an area has been designated for building emergency management. The process makes reference to the following three post-earthquake evaluations:

Figure 1 Building assessment process and subsequent actions when an area has been designated for building emergency management - except simple residential buildings (MBIE, 2020).

- Interim Use Evaluation (IUE)
- Detailed Damage Evaluation (DDE) – developed in response to the 2011 Canterbury earthquake
- Target Damage Evaluation (TDE) – developed in response to the 2016 Kaikoura earthquake.

The TDE is similar to the FEMA P-2335 Preliminary Inspection and the DDE is similar to the FEMA P-2335 Detailed Inspection. It follows then FEMA P-2335 could be used to inform and update the existing DDE and TDE procedures.
