SEISMIC LOAD TESTS ON REINFORCED CONCRETE COLUMNS STRENGTHENED BY JACKETING

M. Rodriguez and R. Park

Department of Civil Engineering

Research Report 92-9

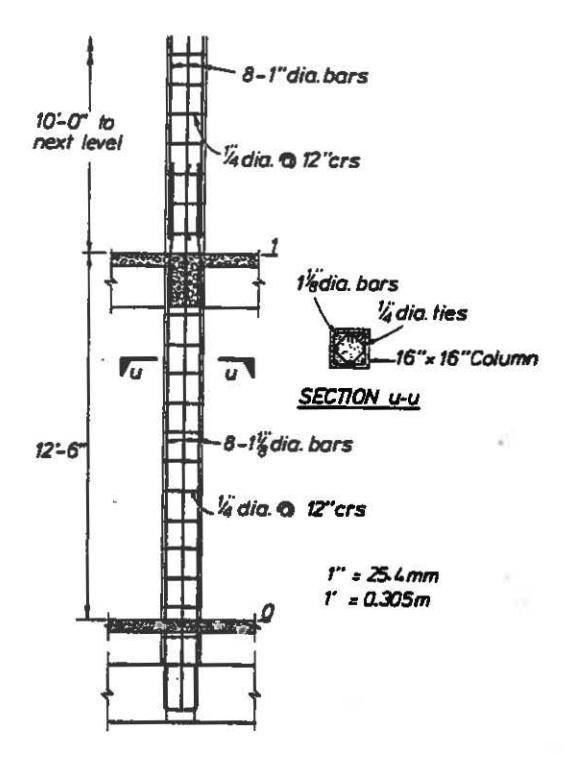
Figure 1 - Dimensions and Reinforcement Details for Typical Column of a Moment Resisting Frame Designed in the Late 1950s.

A typical reinforced concrete column from the lower storey of a seven storey moment resisting frame constructed in New Zealand in late 1950s is shown in Fig. 1. The columns in some regions of this building have inadequate flexural strength to prevent plastic hinging of columns occurring during a severe earthquake. Also, the transverse reinforcement in the columns is inadequate for shear and confinement according to current seismic codes. Although built in New Zealand, the column in Fig.1 may be typical of many of this vintage constructed in other countries of the world.

Four reinforced concrete column units, referred to as Units S1, S2, S3 and S4, were constructed at 7/8th scale to represent the as-built prototype prototype column shown in Fig. 1. The column cross sections were 350 mm (13.8 in) square and the column unit had a height of 3.3 m (10.8 ft), representing the column region between the midheights of successive storeys of the frame. Typical dimensions and reinforcing details of the as-built column units are shown in Fig. 2. Eight longitudinal bars were distributed evenly around the perimeter of the column cross section and the transverse reinforcement consisted of sets of overlaping square hoops as shown in Fig. 2. The stub at the mid-

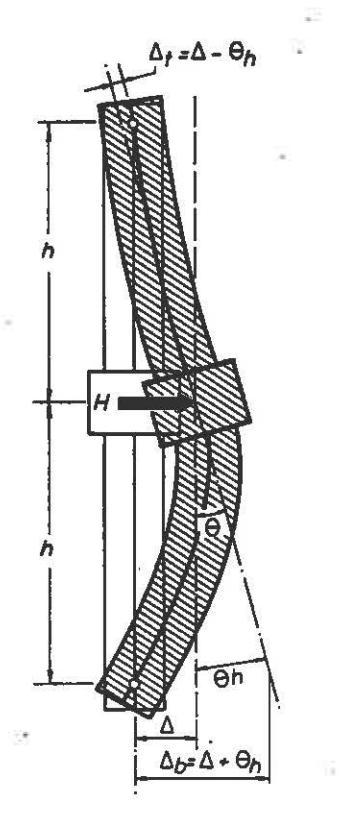
Figure 7 - Effect of Unsymmetrical Plastic Hinge Rotation on Displacements of Column Unit.

Fig. 6 also shows values for the real displacement ductility factor μ_r , which includes the effect of the rotation of the central stub due to the plastic hinge deformations concentrating either above or below the stub. As is shown in Fig. 7, μ_r can be calculated as $\mu_r = (\Delta + \theta h)/\Delta_y$ where θ is the measured rotation of the stub and h is the distance from the centre of the stub to the pin at the end of the column. As is seen in Fig. 6, the value for μ_n of 3 for Units S1 and S4 corresponds to values of μ_r that ranged from 3.6 to 3.9.

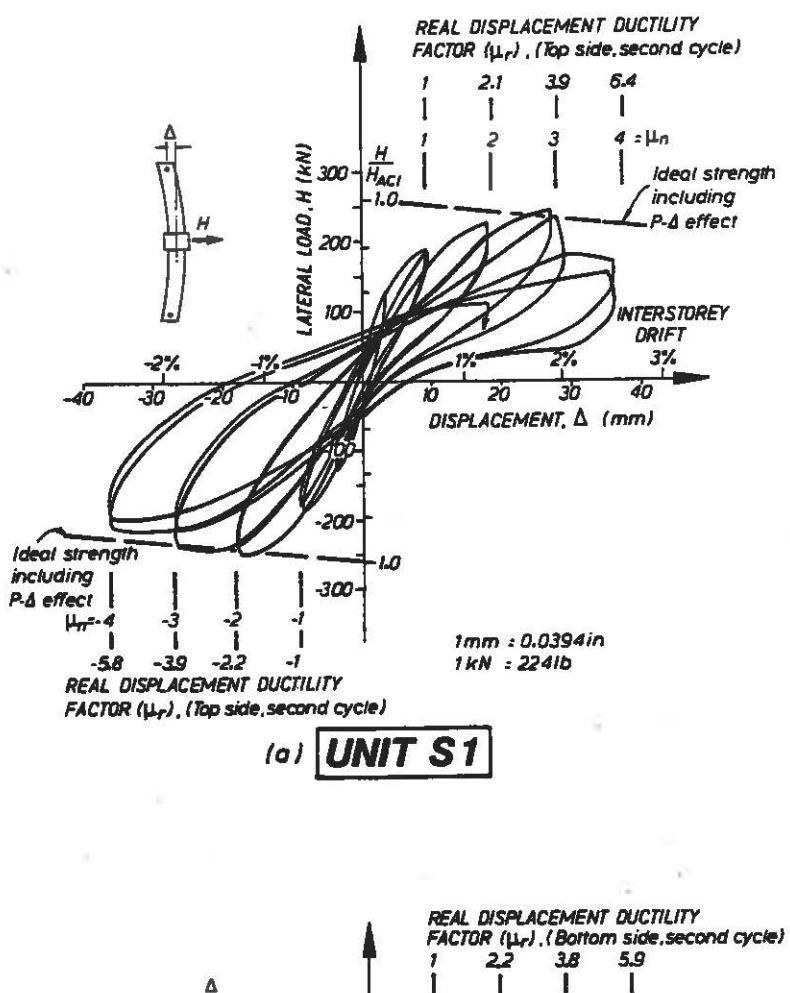
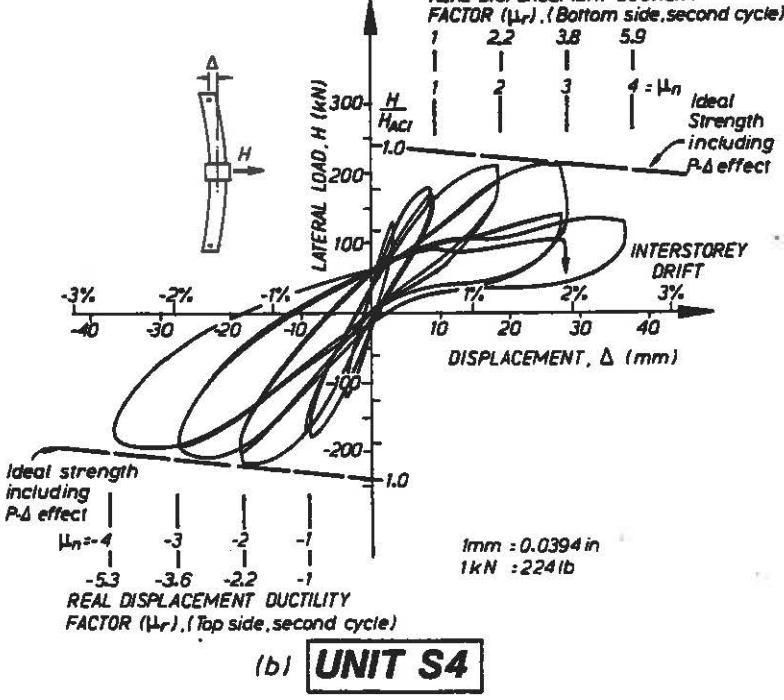
Figure 6 - Measured Lateral Load Versus Lateral Displacement Hysteresis Loops for As-Built Column Units.

Fig. 6 shows the experimental lateral load versus lateral displacement hysteresis loops measured for Units S1 and S4 representing the as-built column. Also shown is the nominal ideal theoretical ultimate lateral load H_{ACI} calculated using the ACI code¹² approach previously described. This theoretical load is plotted as dashed lines which reduce with increase in displacement due to the P- Δ effect. Fig. 6 shows that unlike well confined columns, where significant flexural overstrengths have been measured¹⁴, the measured maximum moments of Units S1 and S4 were almost equal to the nominal theoretical strengths calculated including the P- Δ effect.

Fig. 6 shows that Units S1 and S4 demonstrated a significant reduction of strength after they reached the measured maximum moments which ocurred at μ_n equal to

approximately 3. This was the stage of significant crushing of cover and core concrete. The damage was concentrated mainly in the plastic hinge region above the central stub in the case of Unit S1 (see Fig.4a) and in the plastic hinge regions above and below the central stub in the case of Unit S4.

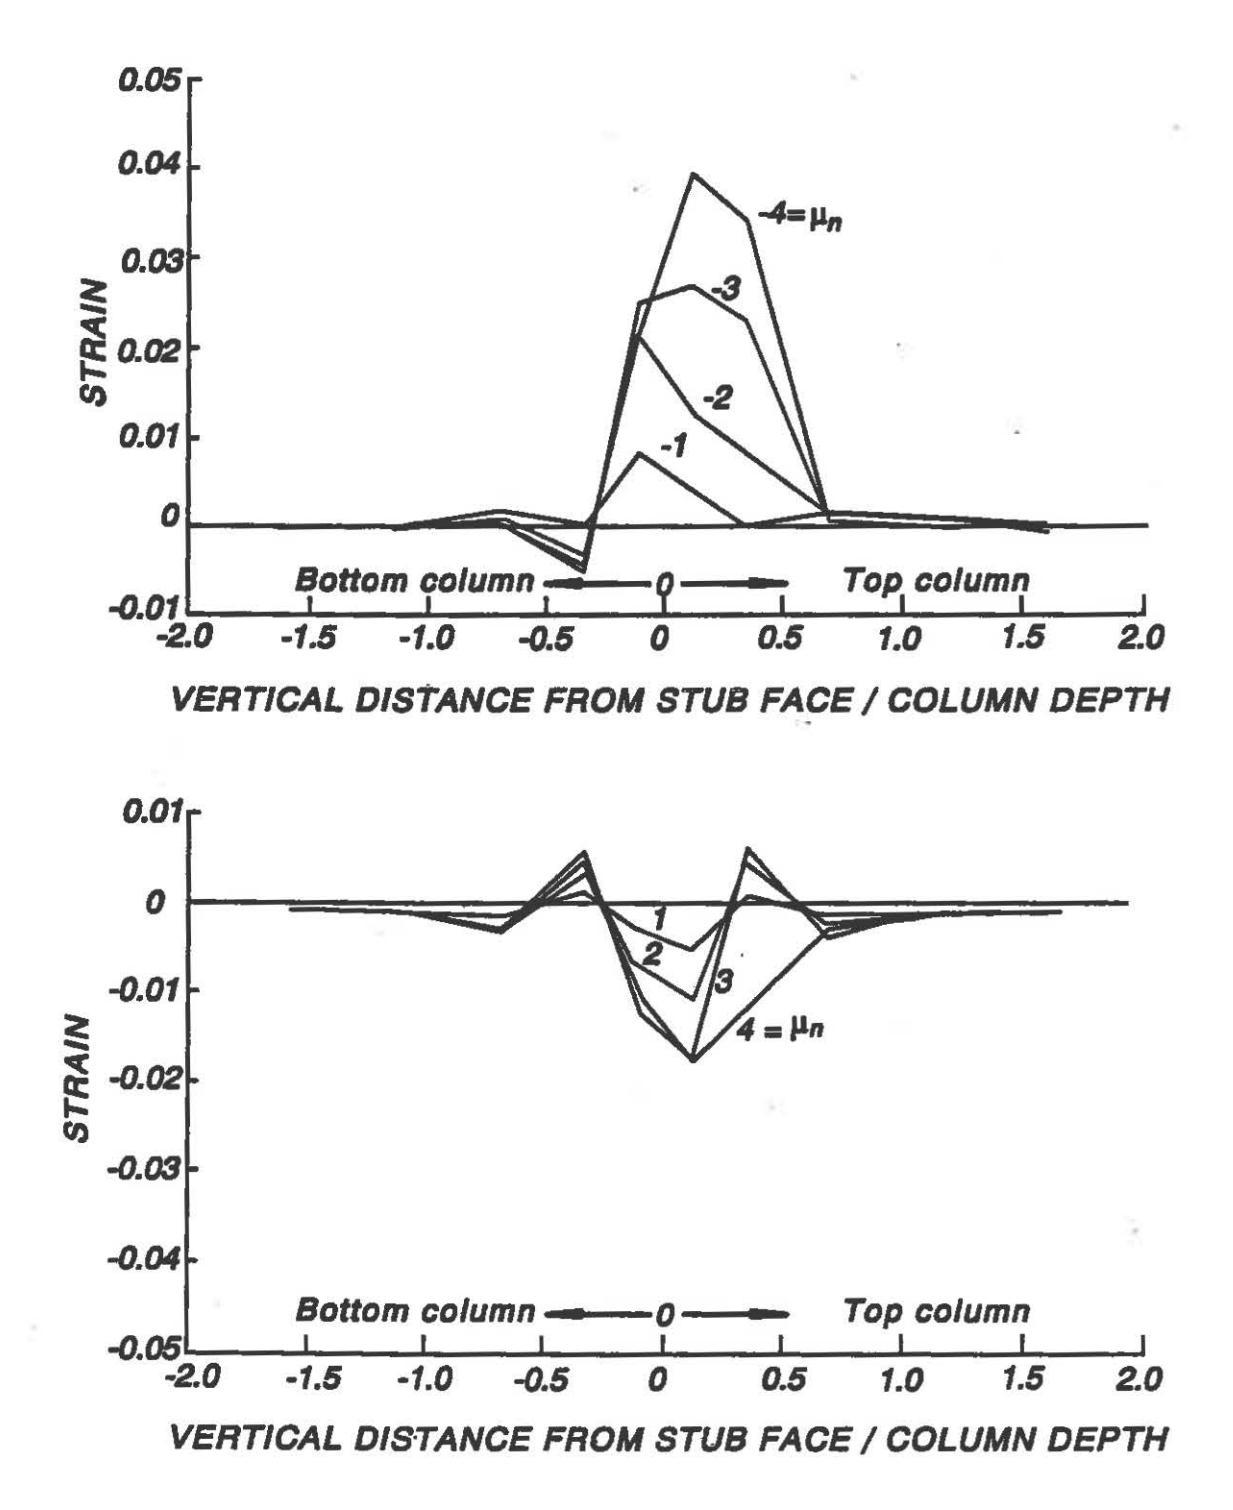
Figure 8 - Longitudinal Strains Measured on Core Concrete by Potentiometers on Unit S1.

Fig.8 shows the variations of longitudinal concrete strain on the surface of the core concrete in the plastic hinge regions of Unit S1 as calculated from potentiometer readings. Fig.9 shows the variation of longitudinal steel strain in the bars of Unit S1 as measured by electrical resistance strain gauges. The differences between the concrete and steel strains shown by the comparison of Figs. 8 and 9 is due to bond degradation

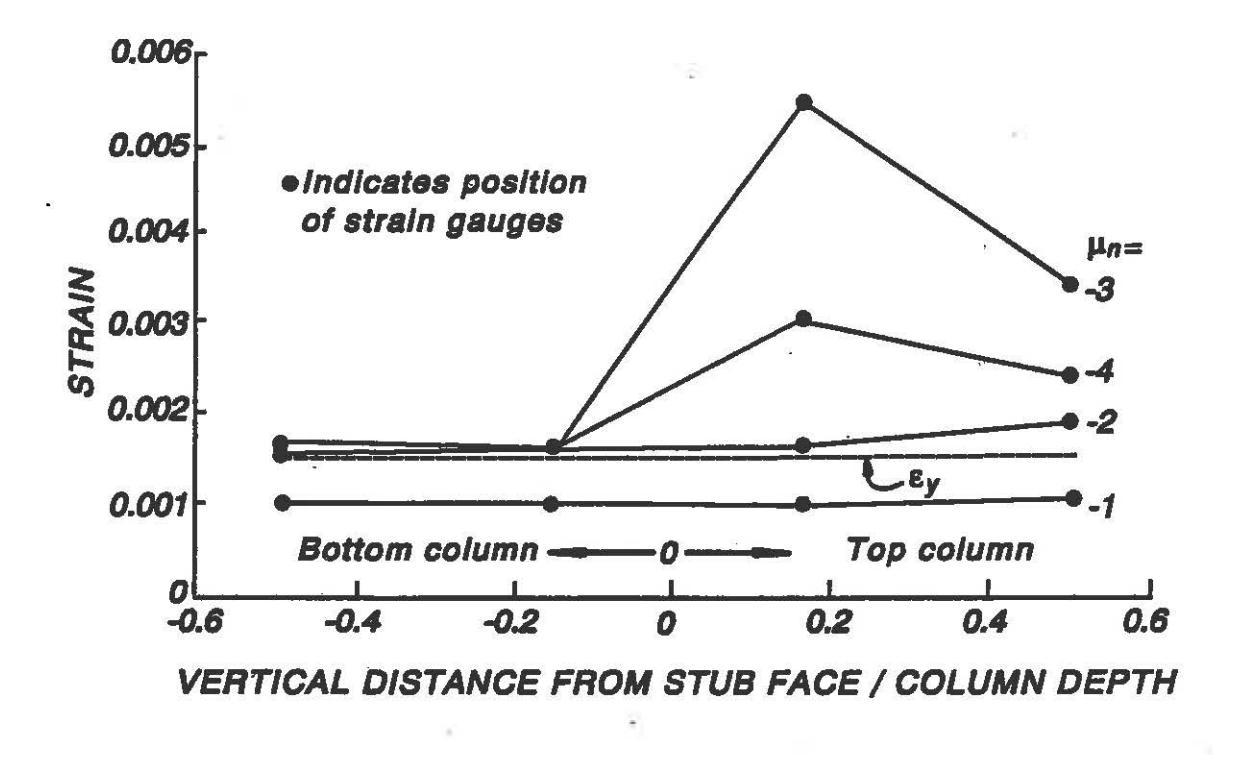
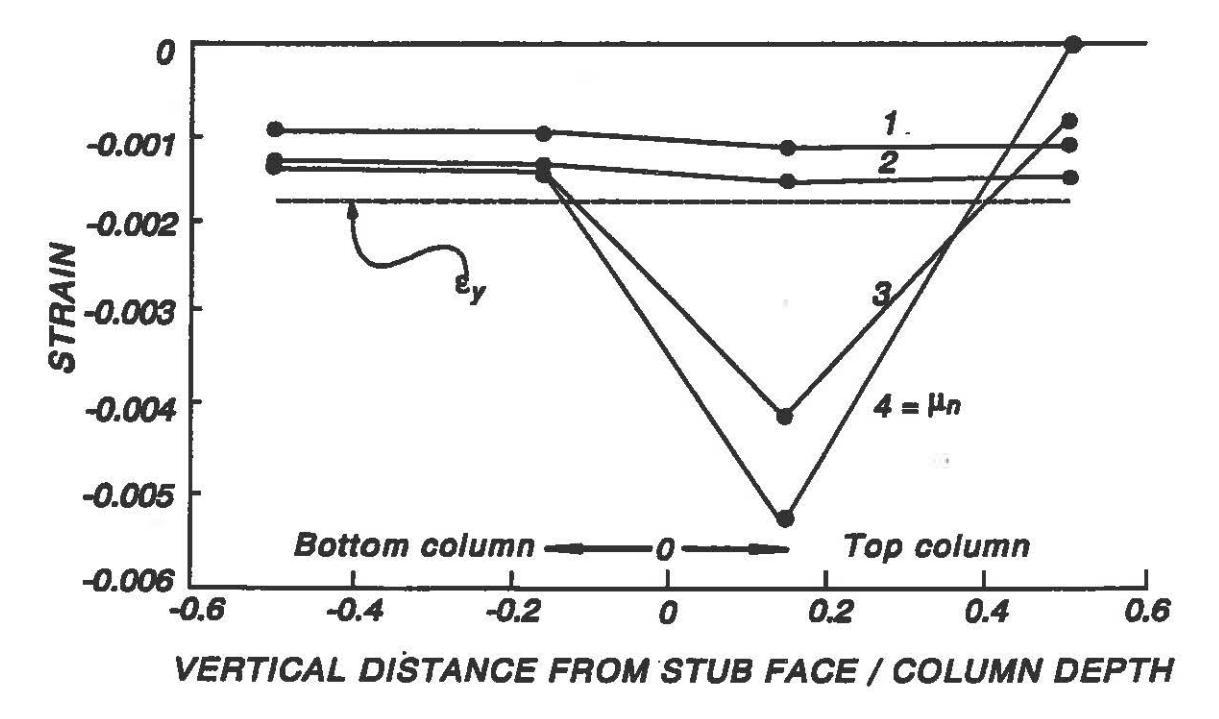
Figure 9 - Longitudinal Strains Measured on Bars by Strain Gauges in Unit S1.

occurring between the concrete and the plain round longitudinal bars during the tests. Similar trends in the measured strains were found for Unit S4.

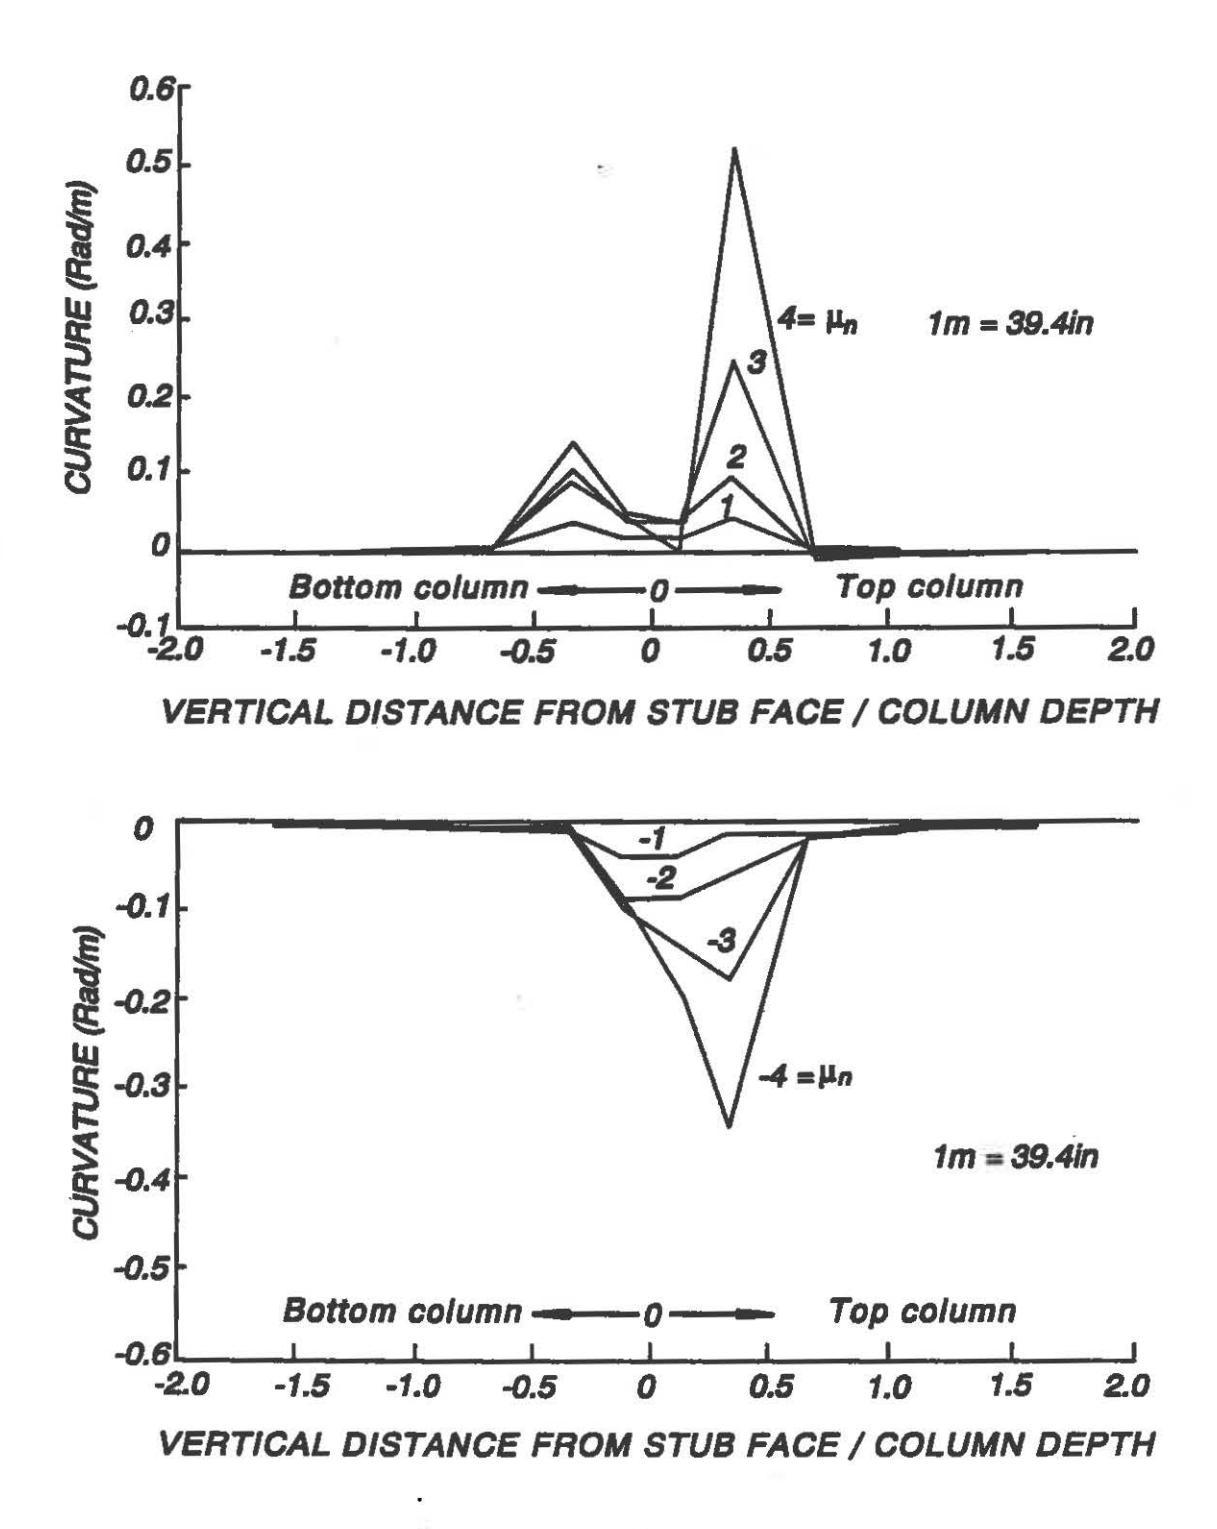
Figure 10 - Measured Curvature Profiles for Unit S1.

Evidence of bond degradation is also given by the curvatures obtained from potentiometer readings for Units S1 shown in Fig.10. It can be seen that most of the inelastic curvature in Unit S1 was concentrated in a plastic hinge length of about $0.5h_c$, where h_c is the column depth. Similar results were found for Unit S4. This concentration of curvature was evidently due to bond degradation leading to one or two main cracks, particularly in the 80 mm (3.15 in) gauge length commencing at 160 mm (6.3 in) from the face of the stub.

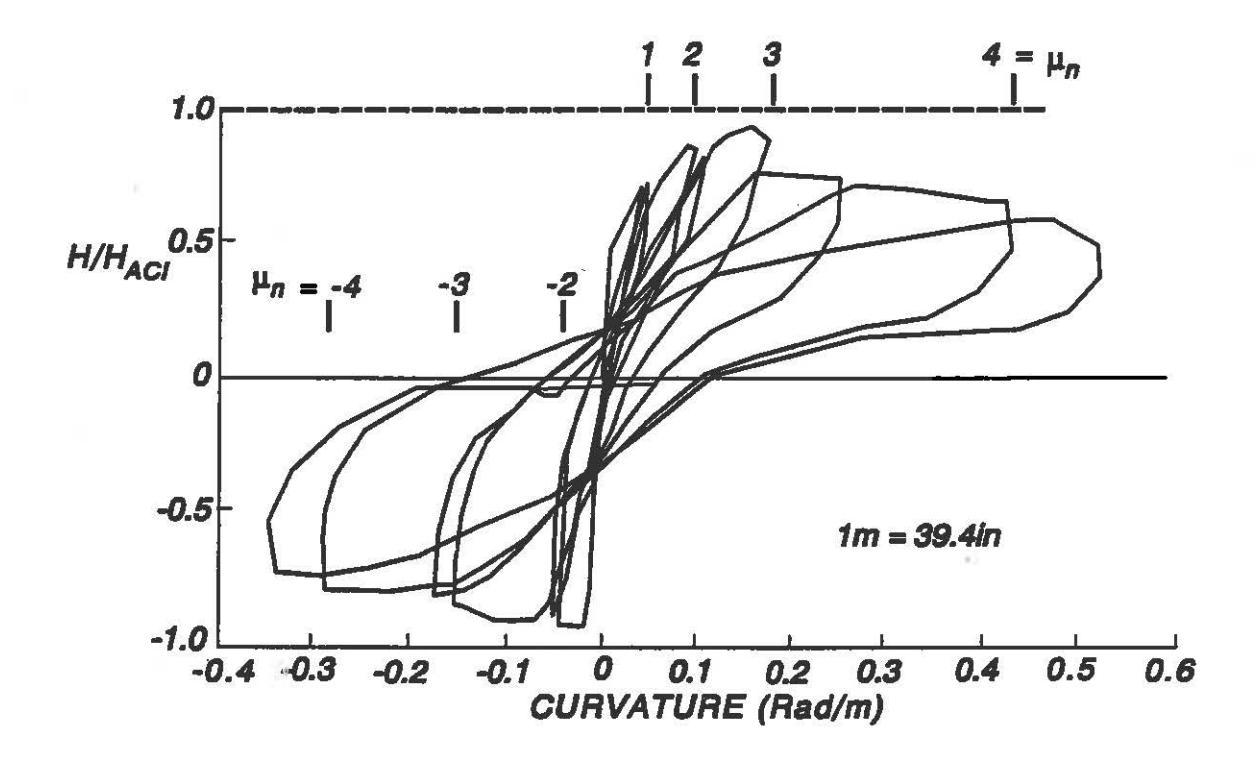
Figure 11 - Measured Lateral Load Versus Column Curvature Above Central Stub for Unit S1.

The lateral load versus column curvature hysteresis loops measured for Unit S1 are shown in Fig.11, where the column curvatures were obtained from the above 80 mm (3.15 in) gauge length. For comparison, the lateral load versus column curvature response predicted by cyclic moment-curvature theory¹⁸ are plotted in Fig. 12. The comparison shows that the experimental flexural strength of Unit S1 was predicted reasonably well by the moment-curvature analysis, but that the experimental column curvatures were greatly underestimated. This would be because the theory did not include the effect of the bond degradation between the plain round bars and the concrete.

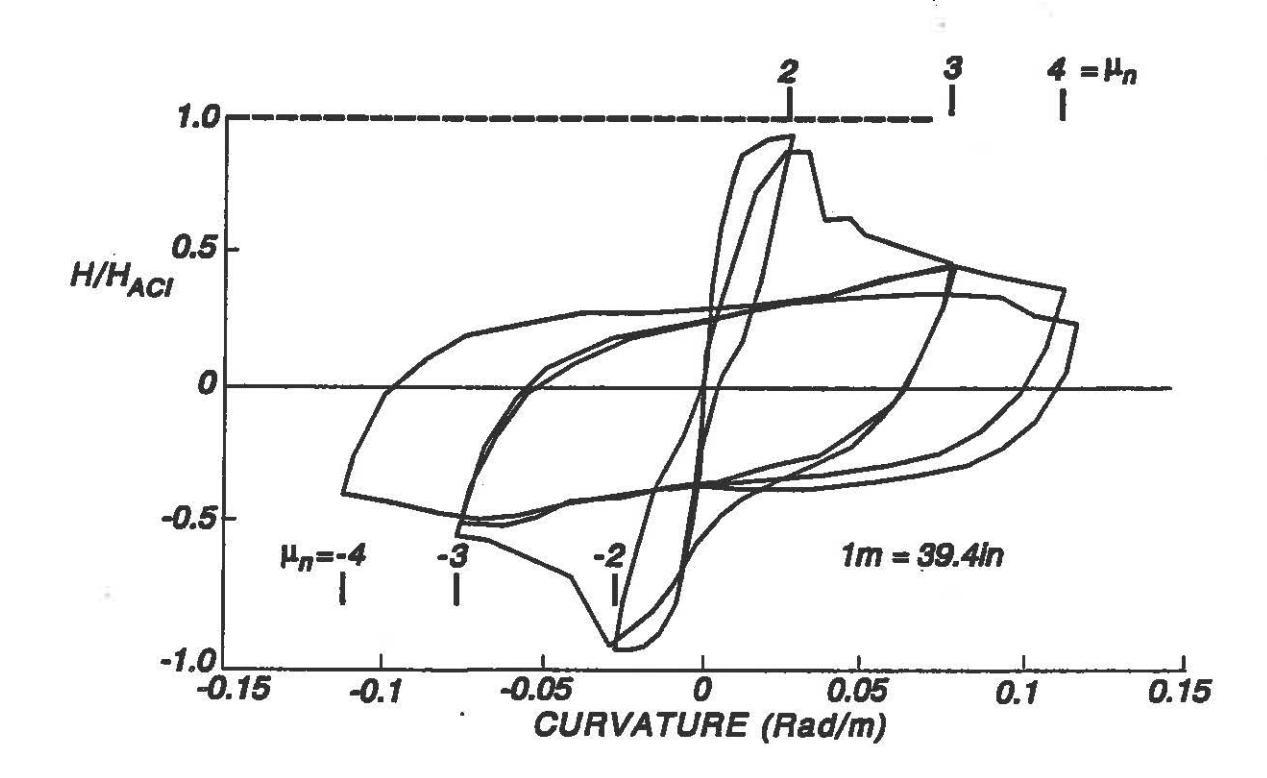
Figure 12 - Theoretical Lateral Load Versus Column Curvature Above Central Stub for Unit S1.

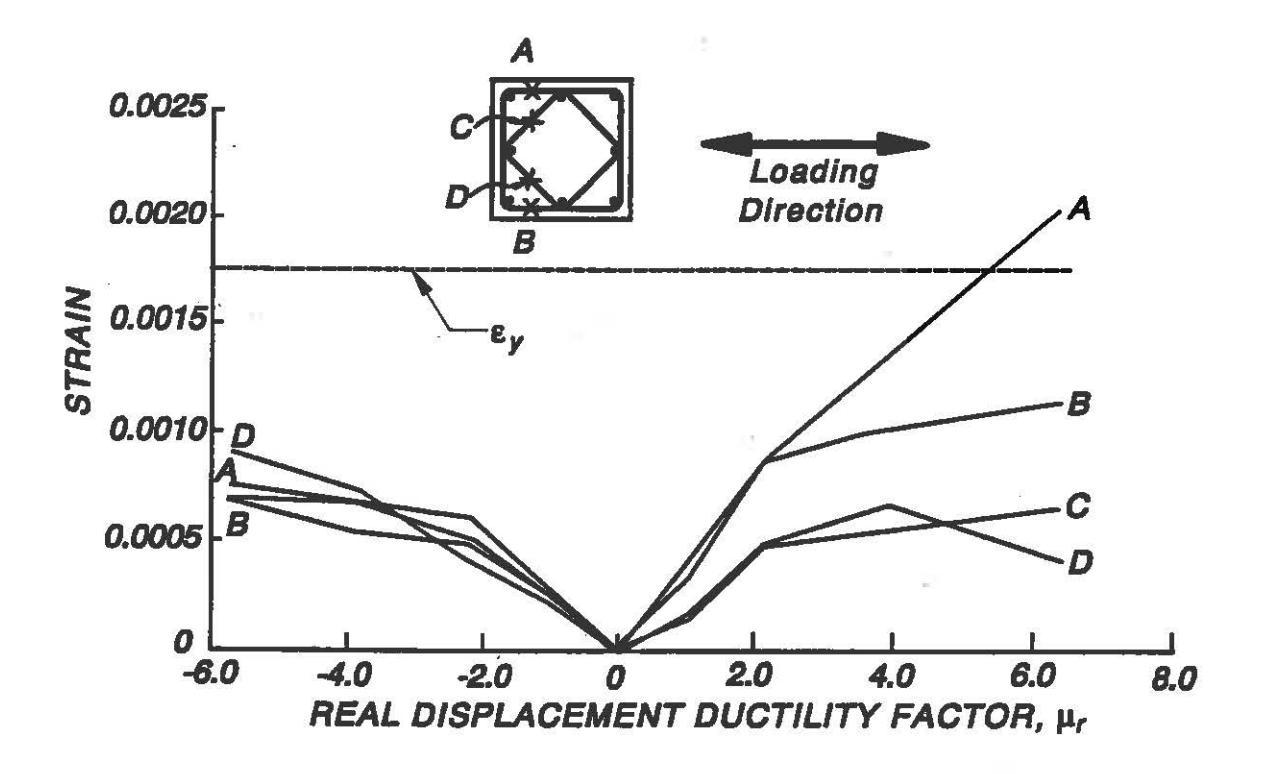
Figure 13 - Measured Strains on Transverse Reinforcement of Hoop Sets Nearest the Central Stub of Unit S1

The measured averaged strains of the hoop sets nearest the central stub of Unit S1 (see Fig.2) are shown in Fig.13. The hoop strains in the damaged region seldom reached the yield strain, even in the final stages of testing. Unit S4 gave similar results.

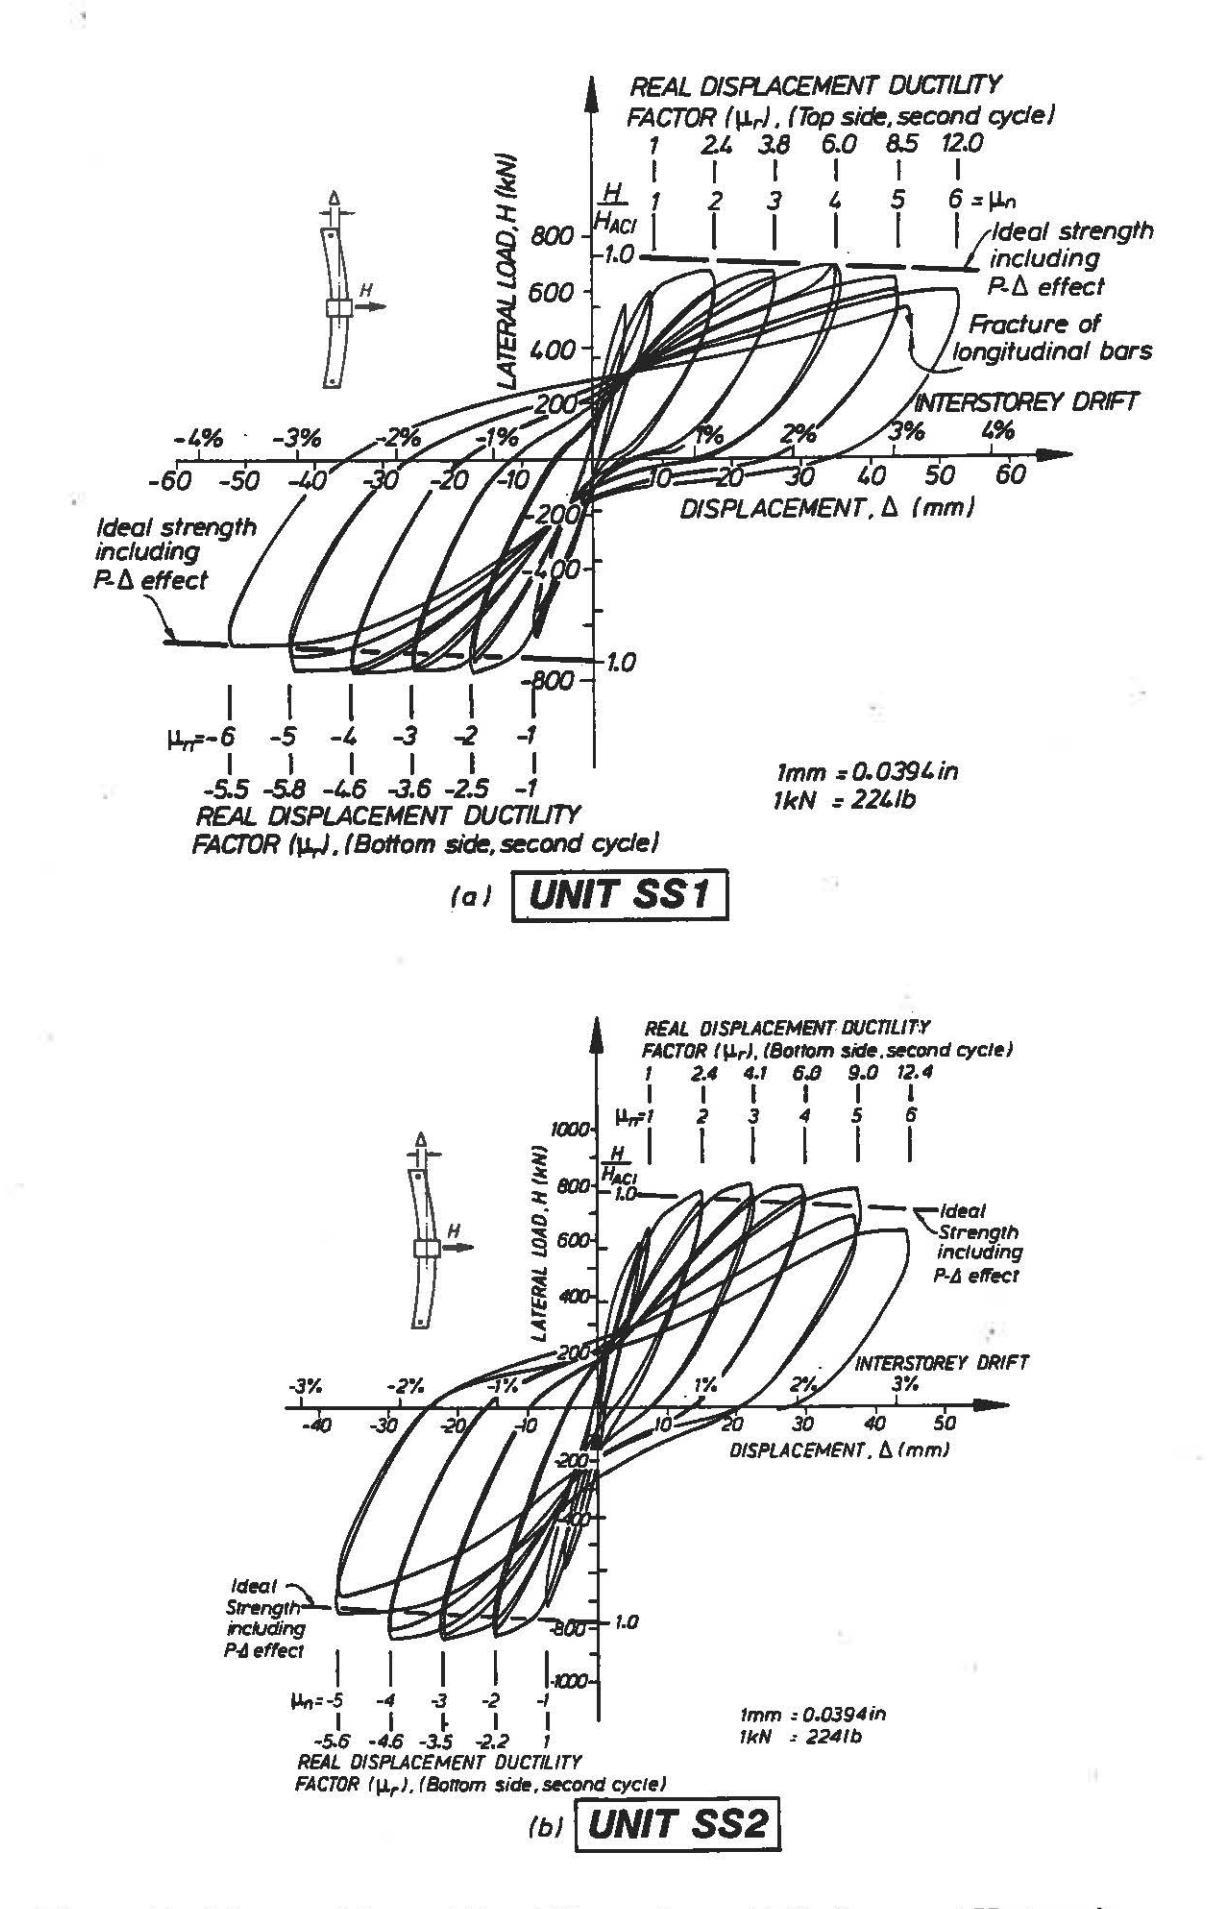
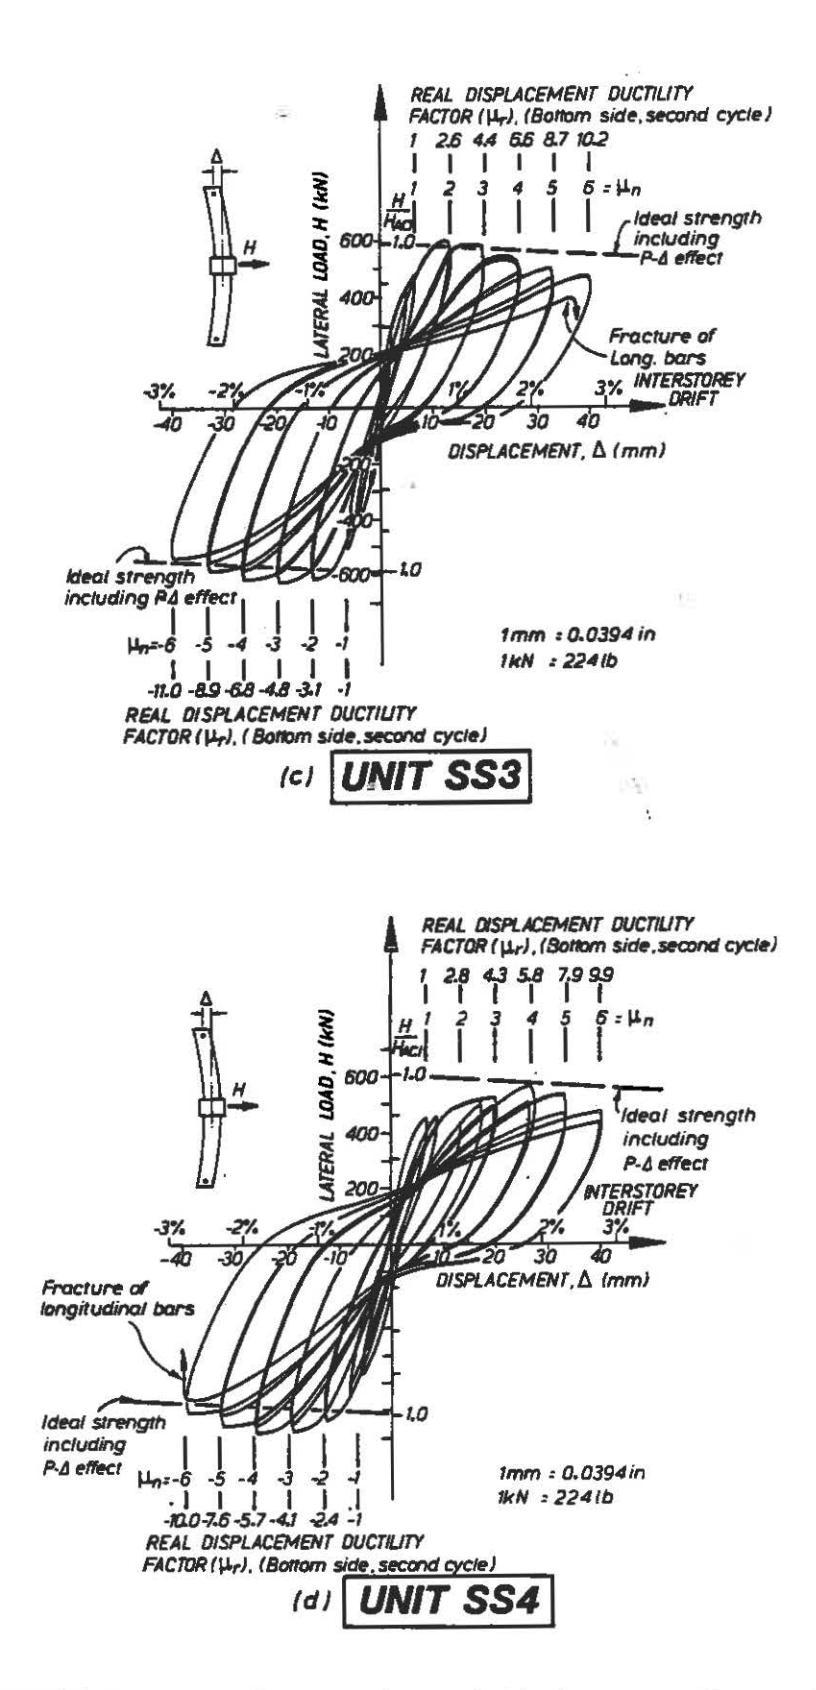
Figure 14 - Measured Lateral Load Versus Lateral Displacement Hysteresis Loops for Jacketed Column Units

Figure 14 - Measured Lateral Load Versus Lateral Displacement Hysteresis Loops for Jacketed Column Units (continued) before retrofitting. This suggests that the previous damage to the as-built columns of Units SS1 and SS4 did not significantly influence the performance of the retrofitted units.

Fig.14 shows the experimental lateral load versus lateral displacement hysteresis loops for the retrofitted Units SS1 to SS4. The measured lateral load versus displacement hysteresis loops for the four jacketed columns indicated good energy dissipation and only a little reduction in strength up to the end of testing. It was observed that each as-built column behaved monolithically with its jacket during the tests. The increase in stiffness, strength and ductility of the jacketed columns can be observed by comparing Figs. 6 and 14. The comparison indicates, for example, that the strength and stiffness of the jacketed Unit SS1 were about three times those for the as-built Unit S1. The ductility achieved by the retrofitted columns was at a level satisfactory for ductile structures. The maximum interstory drifts reached was about 2.8%.

The experimental loops shown in Fig.14 for Units SS1 and SS4, which were damaged before retrofitting, are similar to those for Units SS2 and SS3, which were not damaged

Also, the experimental loops shown in Fig.14 for Units SS1 and SS2 which had longitudinal bars bundled into the corners of the jackets (see Fig.3a), and for Units SS3 and SS4 which had longitudinal bars distributed around the perimeter of the jacket (see Fig.3b), were not significantly different. Hence the bundling of bars in the corners of the jackets of Units SS1 and SS2 had no detrimental effect on the seismic performance of those units, in spite of the fact that these bundles were 438mm (17.2 in) apart and hence exceeded the permitted New Zealand code¹¹ maximum spacing between tied column bars of 200mm (7.9 in). Similar results for bundled column bars have also been found in cyclic lateral loading tests of jacketed reinforced concrete columns conducted at the University of Texas¹⁶.

In addition, these tests indicated that the greater quantity of transverse reinforcement in the jackets of Units SS3 and SS4 than in the jackets of Units SS1 and SS2 (see Table 1 and Fig.3) resulted in no significant improvement in the seismic behaviour of Units SS3 and SS4. That is, for these jacketed columns with relatively light axial loads of $0.1f_c^tA_g$ the lateral load tests showed that the quantity of confining reinforcement recommended by the ACI Code¹² is unnecessarily high. The conservative nature of the ACI recommended quantity of confining reinforcement for columns with small axial load levels has been discussed previously¹⁹.

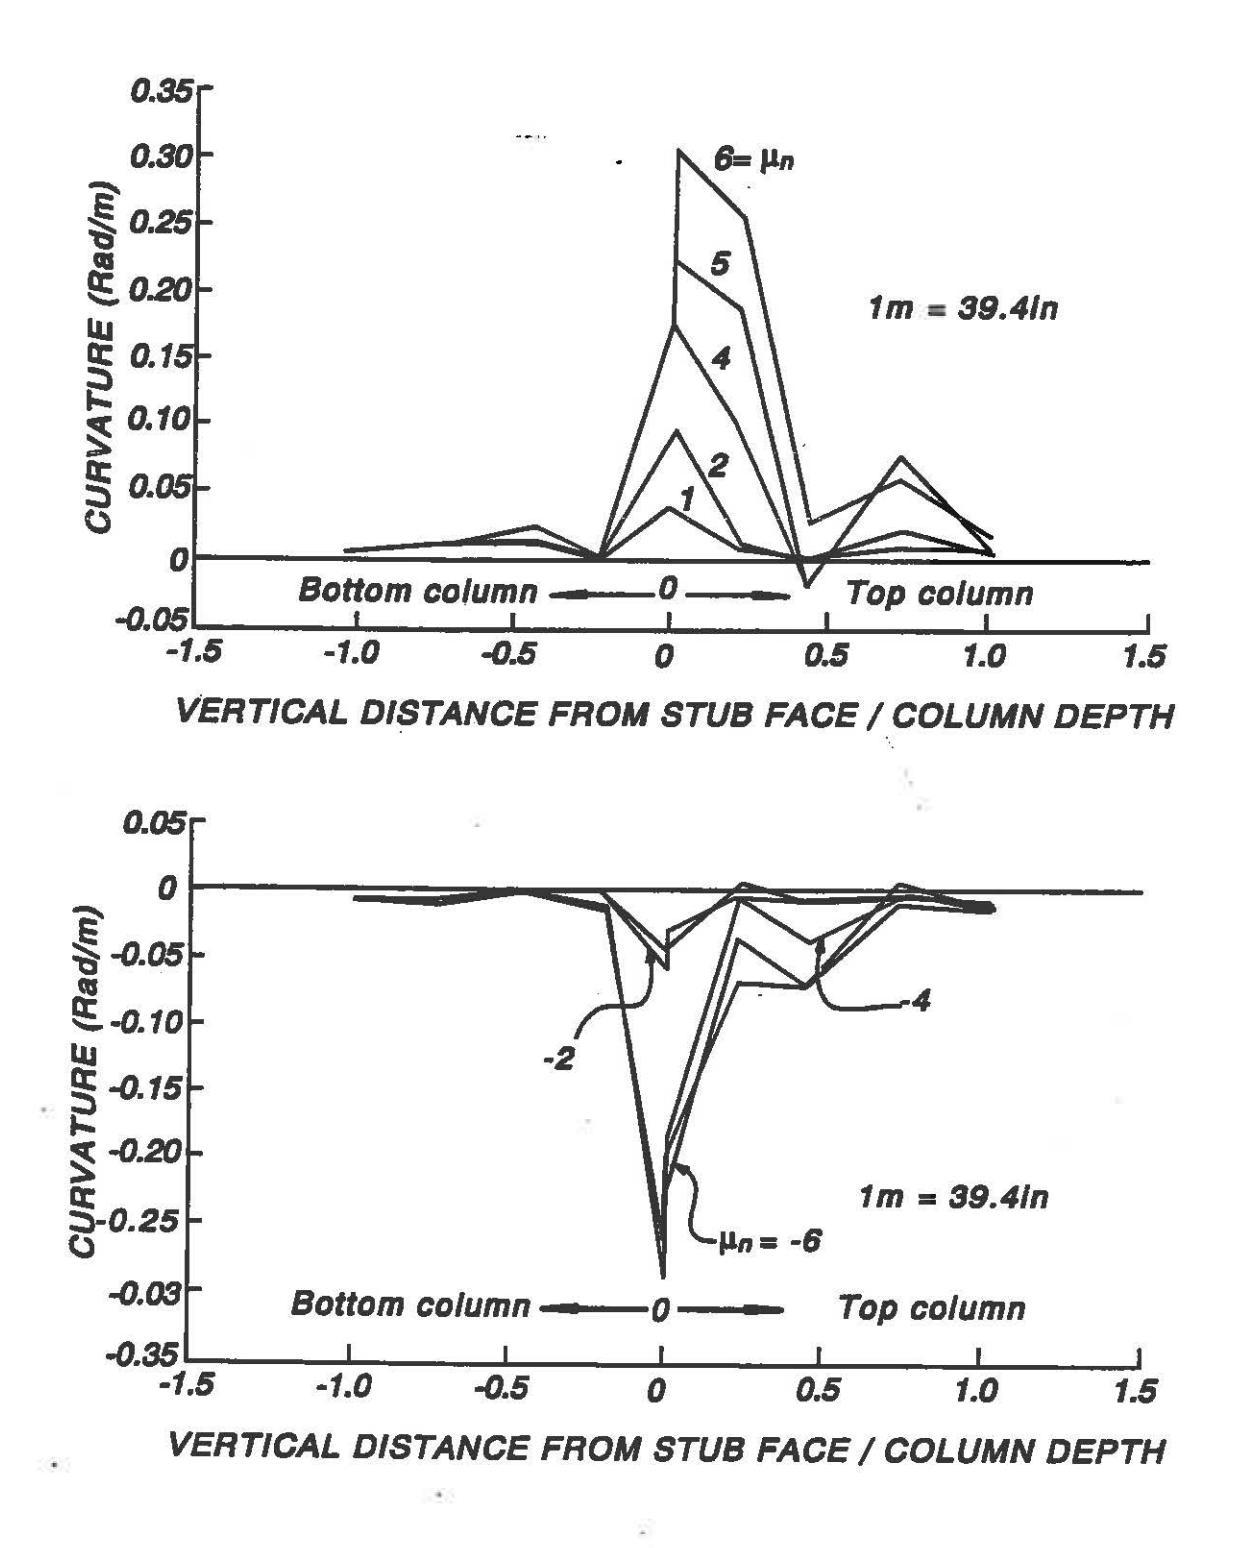
Figure 16 - Measured Curvature Profiles for Unit SS1.

Curvatures obtained from potentiometer readings for Unit SS1 are shown plotted in Fig.16. Fig.17 shows the experimental hysteresis loops for lateral load versus column curvatures for Unit SS1, where the column curvatures were obtained from the readings of the potentiometers above the central stub seated directly against the face of the stub. The lateral load versus column curvatures predicted by the cyclic moment-curvature theory of Mander et al¹⁸ are plotted in Fig. 18. The cyclic moment-curvature theory included the effect of yield penetration of a $32\sqrt{d_b}$ length of longitudinal bar into the stub, where d_b is the diameter of the longitudinal bar in mm. Comparison of Figs. 17 and 18 shows that the flexural strength of Unit SS1 was predicted reasonably well by the theory, but that the theory underestimated the experimental curvatures. For more accurate results, bond slip in the column should also be considered in the theoretical predictions.

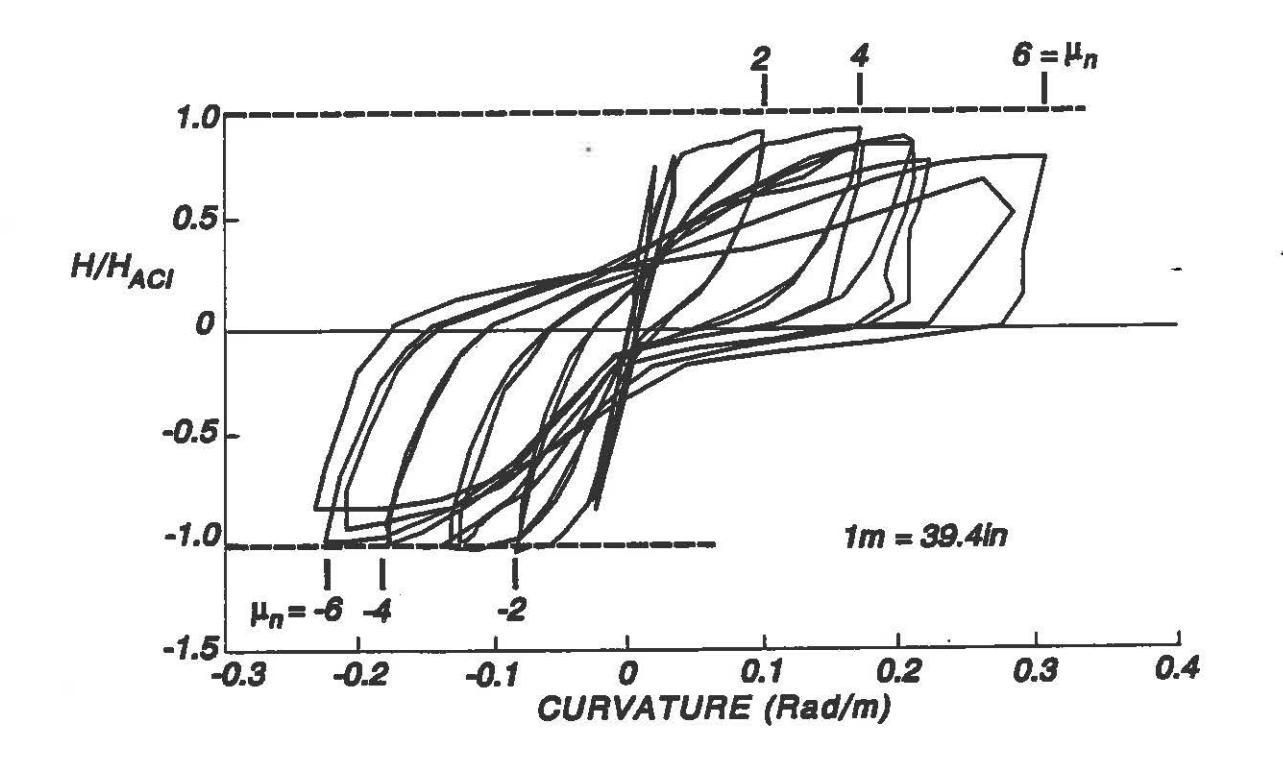
Figure 17 - Measured Lateral Load Versus Column Curvature Above Central Stub for Unit SS1.

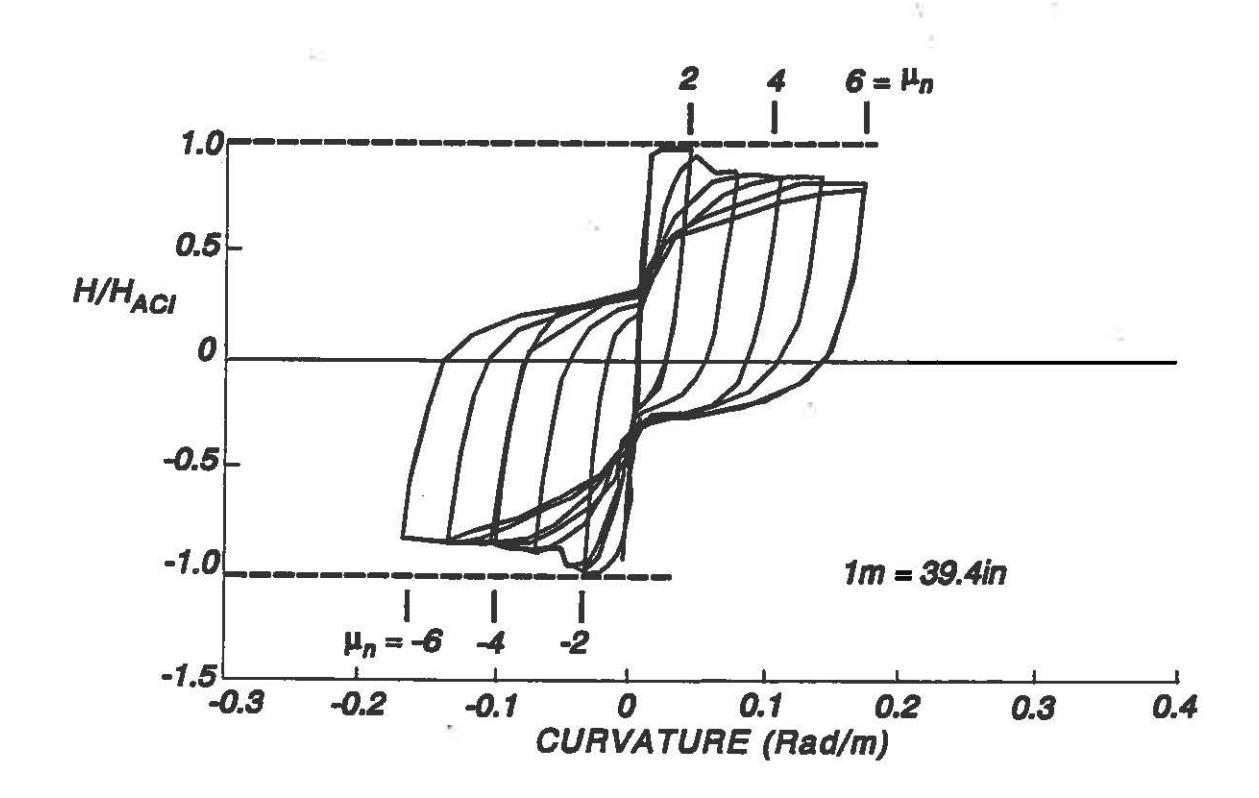
Figure 18 - Theoretical Lateral Load Versus Column Curvature Above Central Stub for Unit SS1.
