The Value of Lifeline Seismic Risk Mitigation in Christchurch

June 2012

This report was commissioned by the New Zealand Earthquake Commission under its 'Science-to-Practice' Programme.

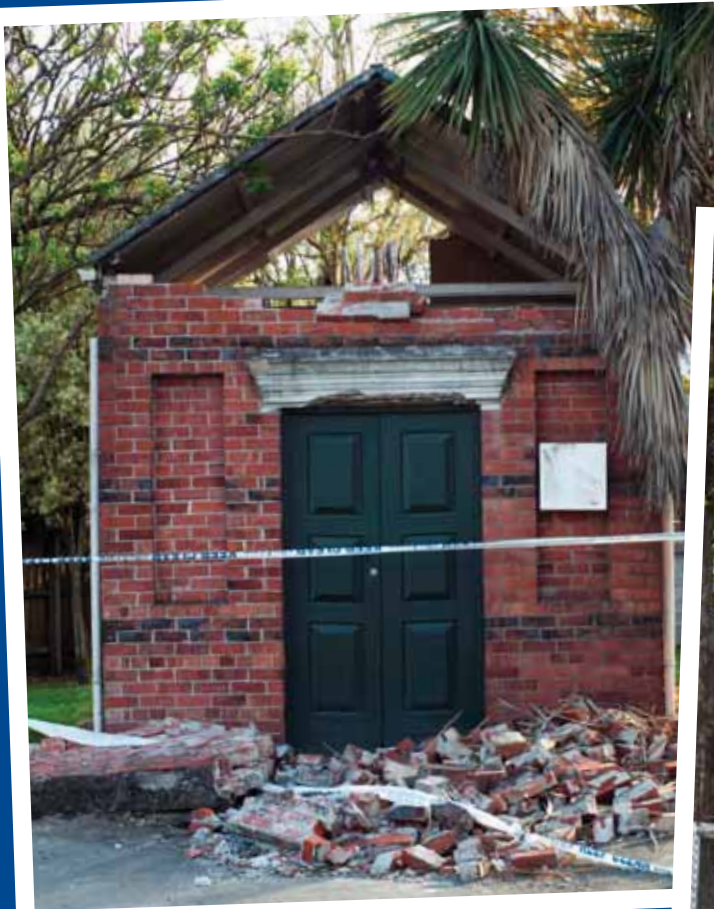
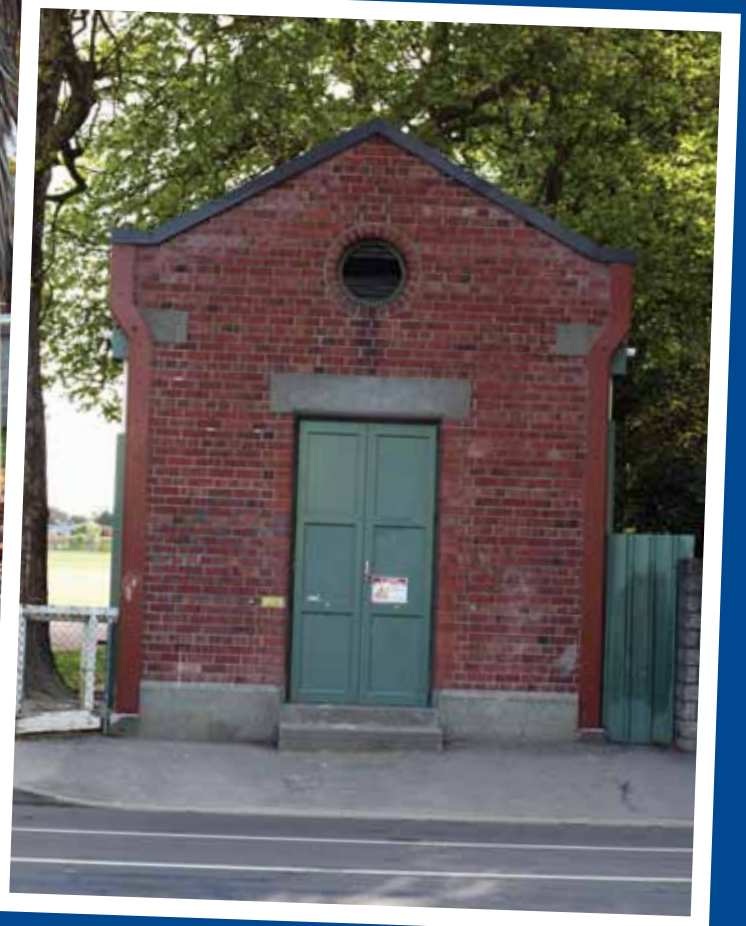
^ This electricity substation had been decommissioned prior to the earthquakes and was unstrengthened

Nearby strengthened electricity substation >

The photos illustrate the value of seismic mitigation, in this case, strengthening unreinforced masonry structures, many of which serve as substations in Christchurch's electricity network. The substation on the left had been decommissioned prior to the earthquakes and was therefore excluded from Orion's mitigation programme (it is no longer owned by Orion). The building was severely damaged in the September 2010 earthquake. The substation on the right, approximately 500 metres away, had been seismically strengthened and was largely undamaged. Strengthening work of this nature greatly assisted electricity restoration in Christchurch following the earthquakes. (Photo source: Orion New Zealand Ltd.)

Orion: Prompted by the work leading to *Risks and Realities*, Orion undertook a seismic strengthening programme commencing in 1996 and progressing systematically each year. By the time of the earthquakes, improved seismic standards had been achieved (or substantially achieved) in relation to district / zone, network and distribution substations, and to major cables including cables over bridges. The seismic strengthening cost \$6 million, an investment estimated to have saved Orion \$60 to \$65 million in direct asset replacement costs and repairs.

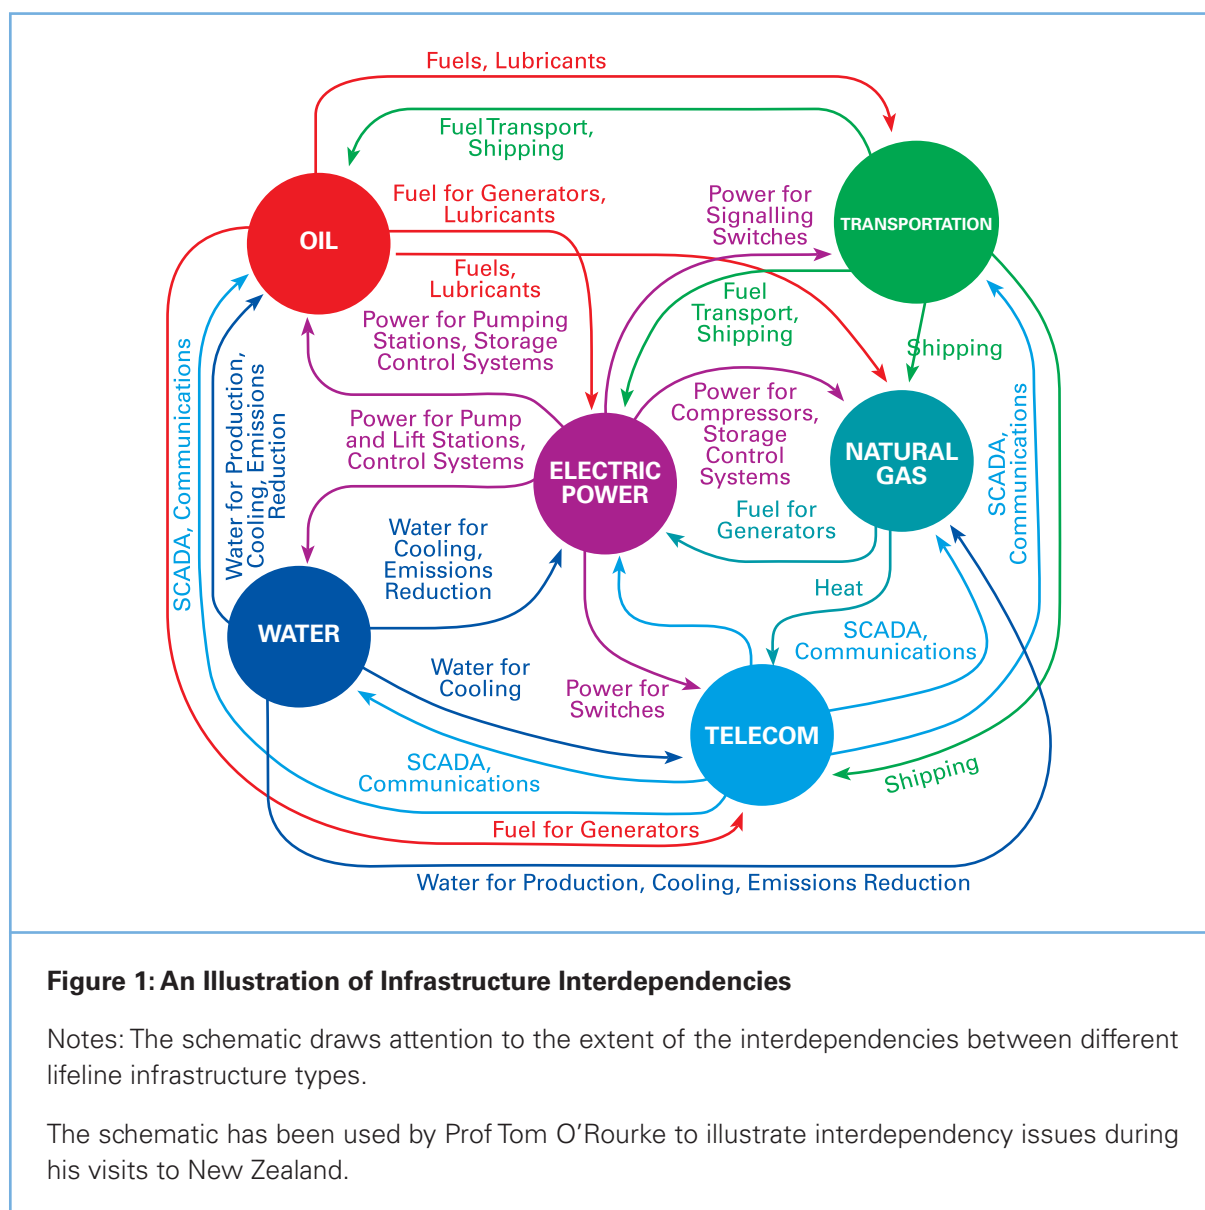
Figure 1: An Illustration of Infrastructure Interdependencies

The businesses that rely on infrastructure include infrastructure businesses (lifeline utilities) themselves. The extensive interdependencies within this central group mean that infrastructure outages can cascade through the economy adding very substantially to overall cost.¹⁹ The following schematic depicts the issue.

Notes: The schematic draws attention to the extent of the interdependencies between different lifeline infrastructure types.

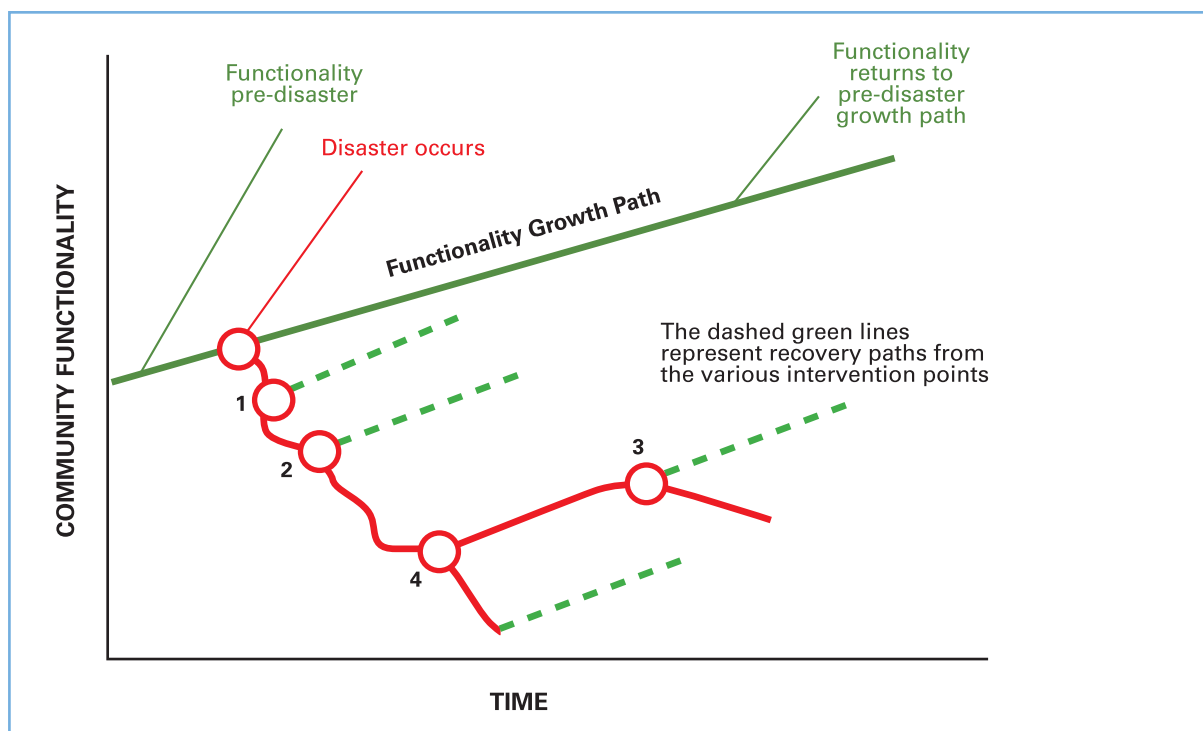
Figure 3: Intervention Points at which Community Loss May be Reduced

Notes: The size of the loss to the community is most effectively reduced by risk reduction action to prevent infrastructure outage (the loss may be stemmed early, at Point 1). Assuming ineffective risk reduction, actions to reduce the risk that infrastructure outages may spread to interdependent systems are depicted as a second line of defence (Point 2). Following commencement of a recovery, Point 3 illustrates gains from avoiding 'second-wave' outages (for example, subsequent outages in systems weakened by the earthquake, for example when aftershocks occur). Point 4 illustrates that major losses can occur if mitigation (risk reduction and readiness) are ineffective.
