**Two-Directional Cyclic Racking of Corner Curtain Wall Glazing**

*S J Thurston and A B King, BRANZ*

NO. 44 (1992)

BRANZ Study Report SR 44

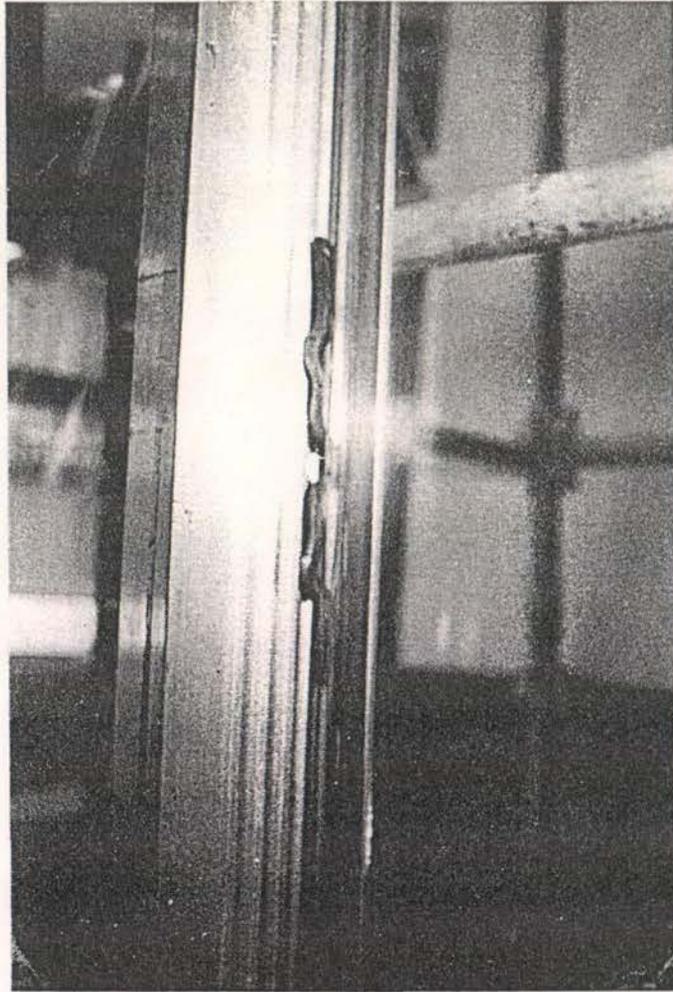
Neoprene spacers (Figure 8), also called antiwalk blocks, were used between the mullions and glass at about 460 mm from the corners. The blocks were installed correctly with the long sides parallel with the glass face. The photograph in Figure 8 shows this block badly distorted from the imposed glass racking. Setting blocks (Figure 8b) were used below the glass to support its weight at about 360 mm in from the corners. There was no spacer between the glass and the frame above the window.

(a) Distortion of neoprene spacer (antiwalk blocks)

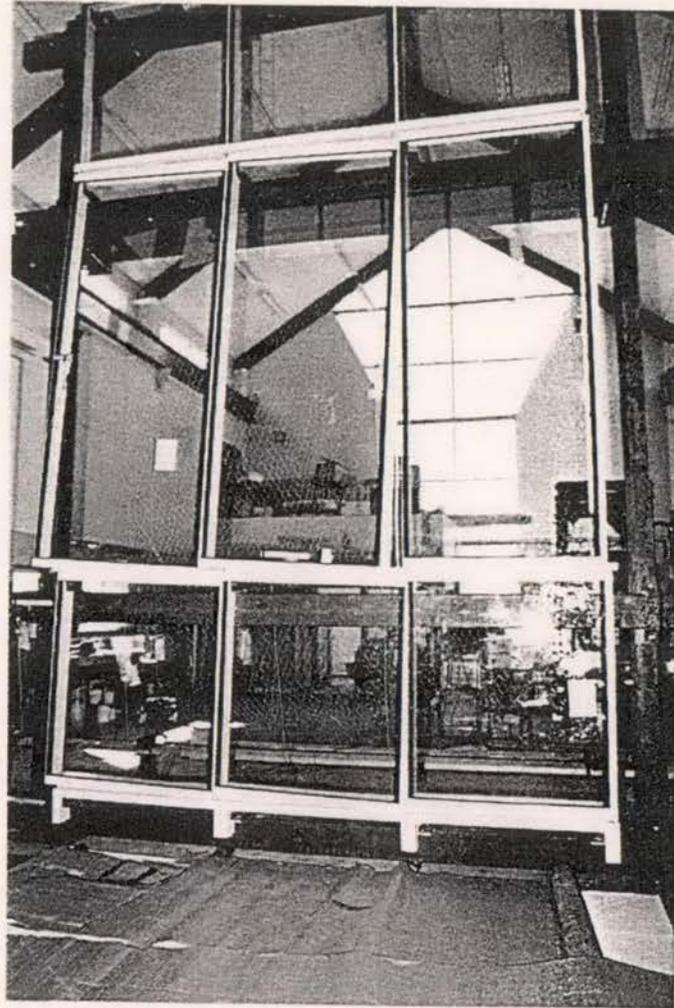
Figure 11f Distortion of planar wall four-sided silicone system.  
(From Lim & King 1991a)
