# Earthquake Reconnaissance in Bangkok, Thailand, following the 28 March 2025 Mandalay Earthquake

Prepared by: Andrew Stolte, Catalina Miranda, Andrew Baird, Jitendra Bhatta, Jitendra Bothara, Chungwook Sim, and Lucas Hogan

March 2026

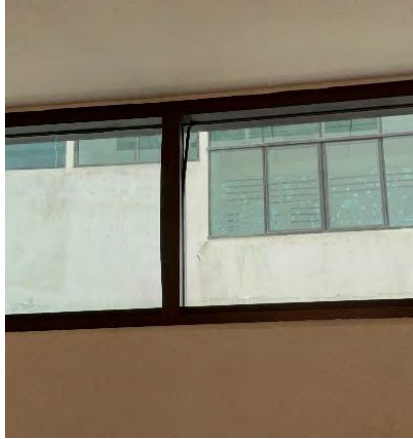
*(g) Dislodgement of window gasket*

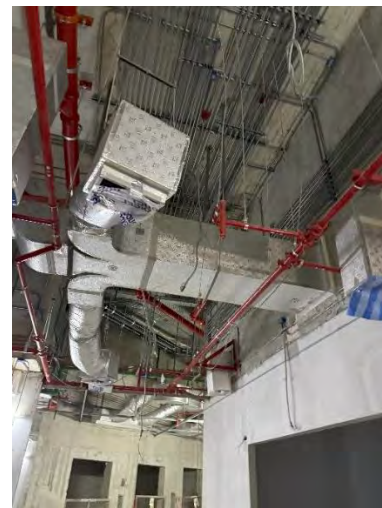
(b) Typical hanging arrangement of services conduit system

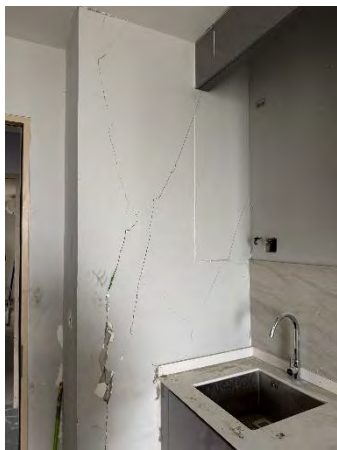
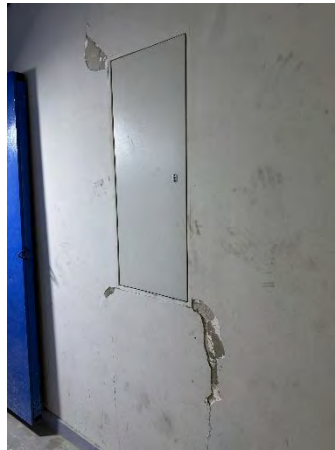
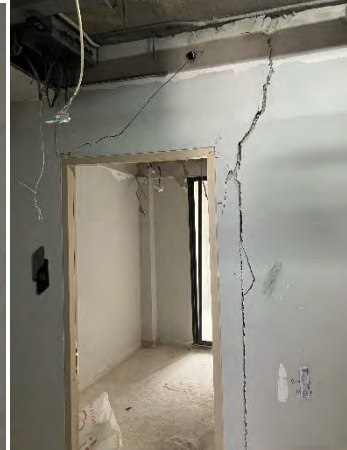
(a) Damage to infill walls on 8<sup>th</sup> and 9<sup>th</sup> stories (typical)

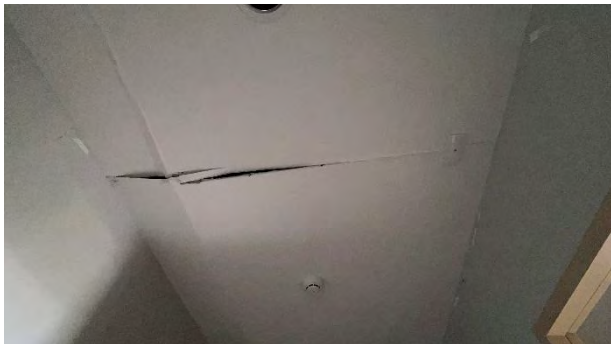
(b) Damage to plasterboard ceilings on 8<sup>th</sup> and 9<sup>th</sup> stories (typical)
